Southwark, Lambeth and Wandsworth

Cycling and Traffic Management Partnership – 30 Sept 2015 (7am to 9am ride)

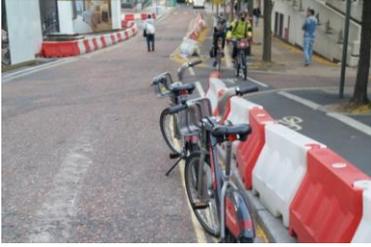
<p>Why are barriers on North side over cycle track?</p> <p>If needed, should barriers be filled with water to stop them drifting into road or cycle track?</p>	<p>Barriers requested to be made safe and even on ride.</p> <p>PM to escalate with Southwark and developers for who is responsible for TM at site.</p>

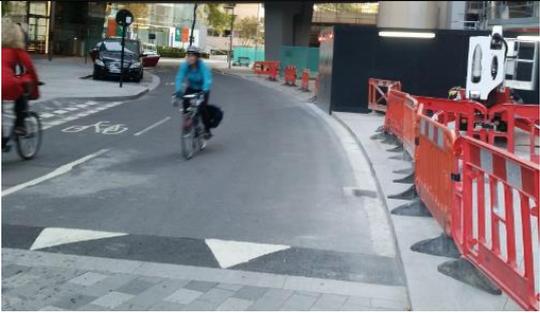
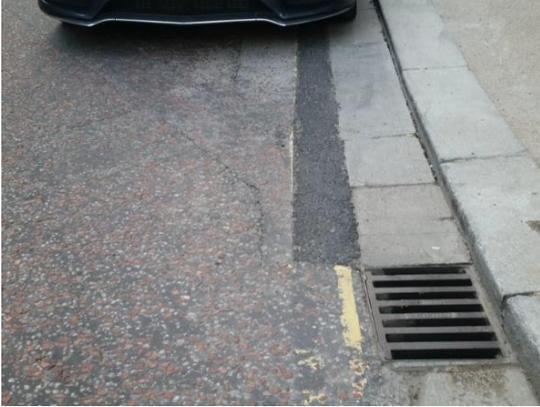
<p>Why are single or double yellow line parking restrictions left missing, covered over with tarmac, or not clearly maintained?</p>	<p>This has been raised at the Blackfriars working group and the Upper ground Monitoring group.</p> <p>Southwark council to investigate.</p>

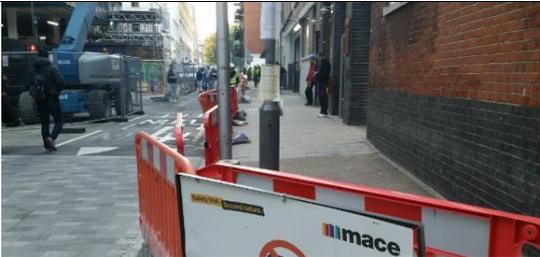
<p>Why are pedestrians barriers left in situ if not required?</p>	<p>Southwark council to investigate.</p>

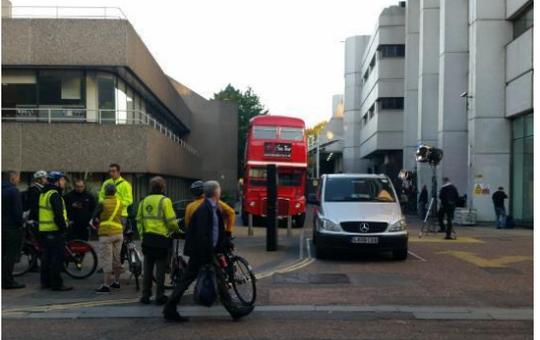
<p>Developer update on Garden Bridge. Time restricted access to river discussed during development.</p> <p>Poor carriageway surface along Belvedere and Upper Ground.</p>	<p>Lambeth and SBEG to be consulted re required pavement improvement plan</p>

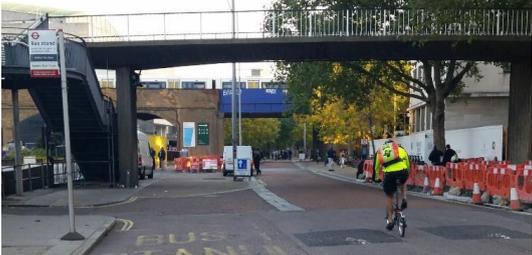
<p>Shell bridge due to removed from next week, but no advance warning installed by Lambeth to pedal or vehicle mode</p>	<p>Signage issue escalated to developer same day now in place</p>
<p>Zone 3. Vauxhall Tavern</p>

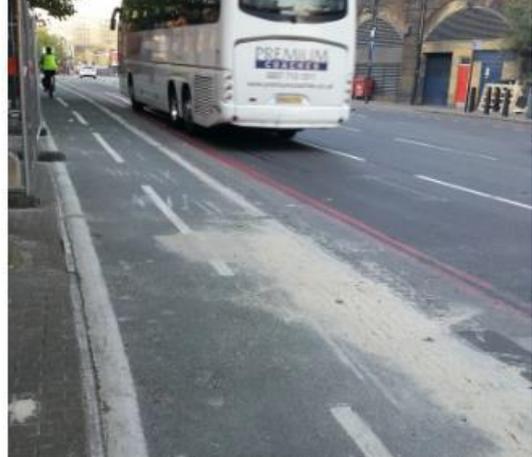
<p>Sand slip hazard not cleared (close to contractor storage materials)</p>	<p>AL to action</p>

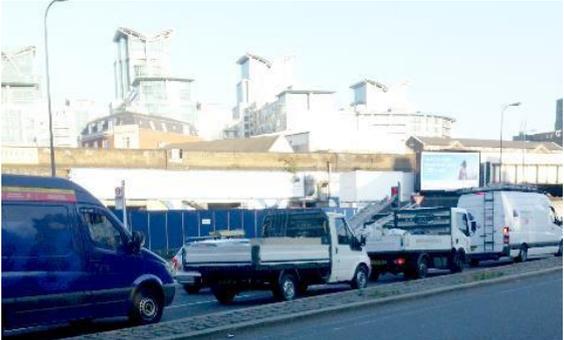
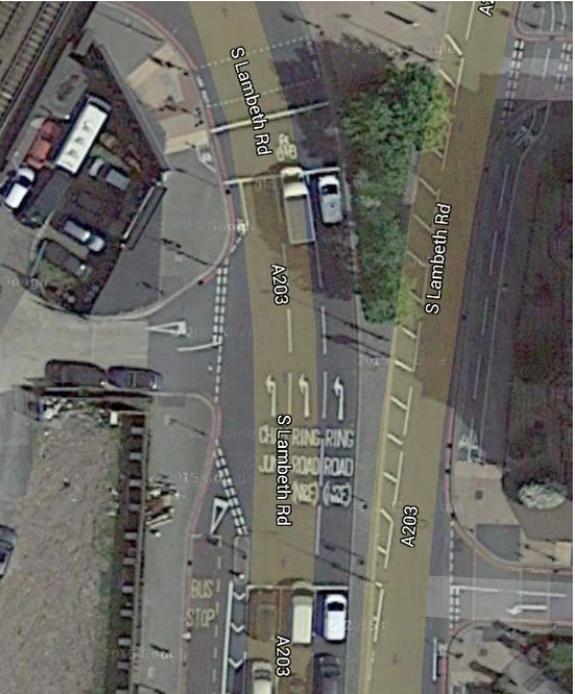
<p>Northbound, major new development will remove the bus/pedal mode segregated "gate" to accommodated site deliveries. TBC</p> <p>Is there potential to provide a pedal route for Northbound pedal mode to the 2-way cycle track and connect with Vauxhall CSH?</p>	<p>MB to review original scheme approval</p>

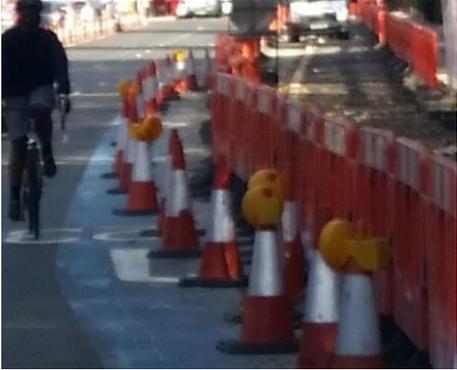
<p>What was the reason for cones placed ~1m away from barriers (towards Brixton Road)?</p>	<p>PW to review</p>

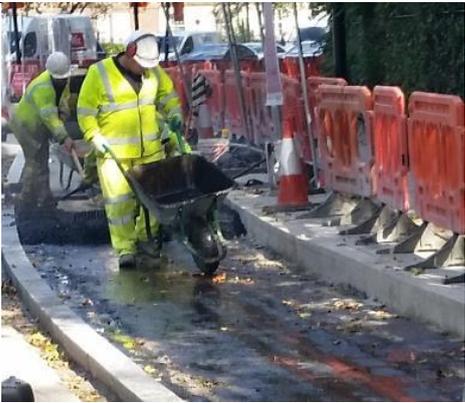
<p>Will the new cycle track at Oval (Brixton Road) be smooth and without surface defects?</p> <p>Existing “uneven” track surfaces at Oval unresolved.</p>	<p>PW escalate response from contractors.</p>

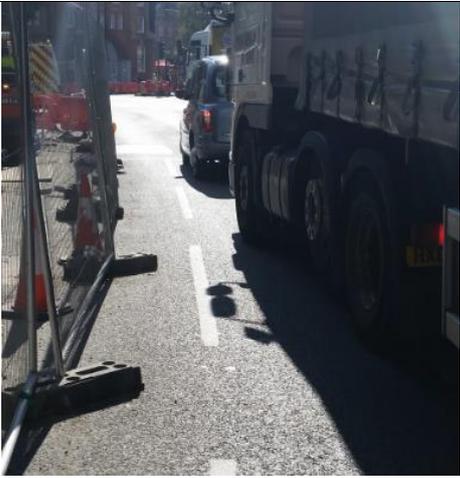
<p>Brixton Road at Oval Southbound. Heras fencing support blocks missing warning cones. Potentially dangerous to cycle mode at night when blocks stick out.</p> <p>Uneven fencing line without cones, creating pinch point.</p>	<p>PW escalate to contractors.</p>
<p>Zone 4. Brixton Road</p>

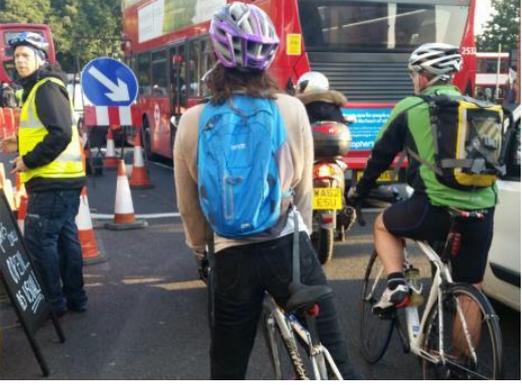
Zone and location Item	Comments	Actions/Responses
<p>1/

</p>	<p>1/ Guidelines suggest an advisory arrow is needed at the start and end of TM road narrowing.</p> <p>As seen, the very large arrow and cones causing severe pinch point to pedal mode.</p> <p>2/ Area has significant pedestrian desire line to bus stops and shops, but there are no barrier breaks for pedestrian safety.</p> <p>Could cone mounted type TM signs be used in comprised sites?</p>

<p>On the day, signage removed.</p> <p>PW to review TM regarding pedestrian flows as being seen.</p>

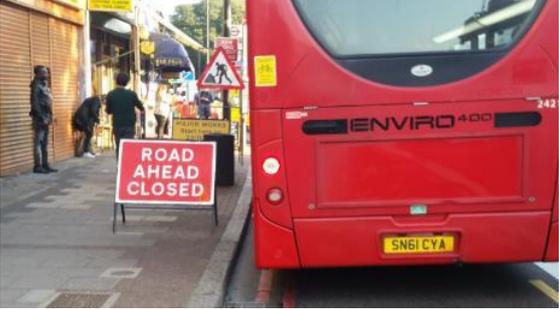
<p>Advance warning signs (before Prima Road) obscured by buses at multiple bus stops and bus standing (often three buses in a row). "Narrow lanes" and "no left turn" signs obscured.</p>	<p>PW to review TM</p>

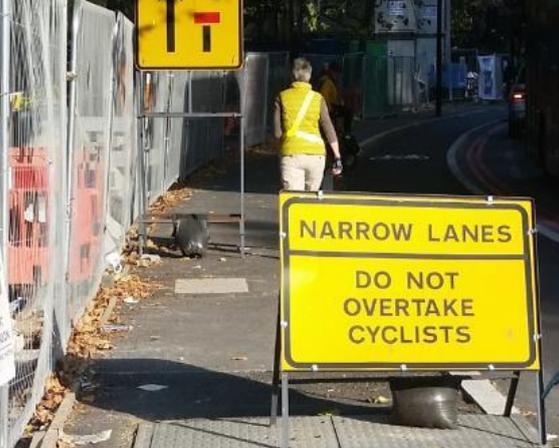
<p>Northbound, (at triangle on Brixton Road) poorly sited TM signage on footway.</p> <p>Insufficient width/layout to pedestrians and wheelchair, pushchair/family users.</p>	<p>PW to review</p>

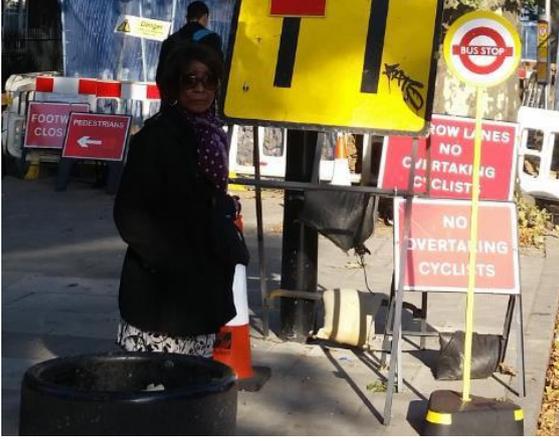
<p>New (temporary) bus stop Northbound by Clayton Street. Can TM street clutter be improved?</p>	<p>PA to review</p>

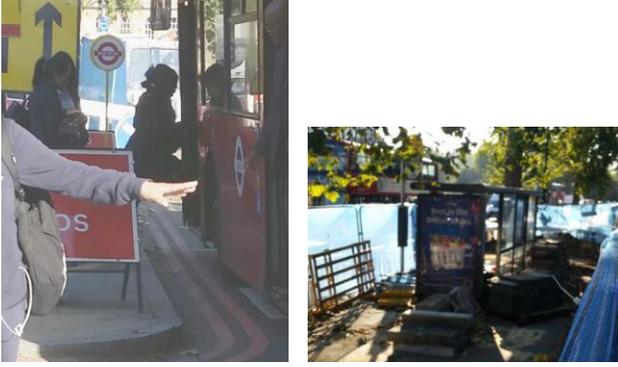
<p>Location of (temporary) bus stop means buses are regularly seen not to stop close to curb for <u>bus entry</u>.</p> <p>Passenger <u>bus exit</u> not aligned to pavement curb.</p> <p>A second bus seen stopping over mouth of side road.</p> <p>Old bus stop seems to be used for material storage area.</p>	<p>PA to review bus stop location</p>
<p>Zone 6. E&C – London Road (Southbound)</p>

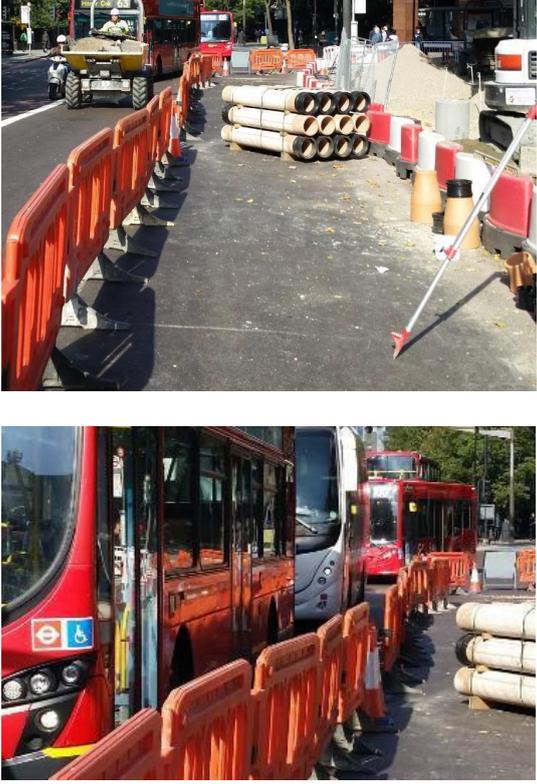
<p>Why is secondary barrier so wide? Putting vulnerable road users at greater risk and conflict Southbound London Road.</p>	<p>DM to comment</p>
<p>Zone 6. E&C – London Road</p>

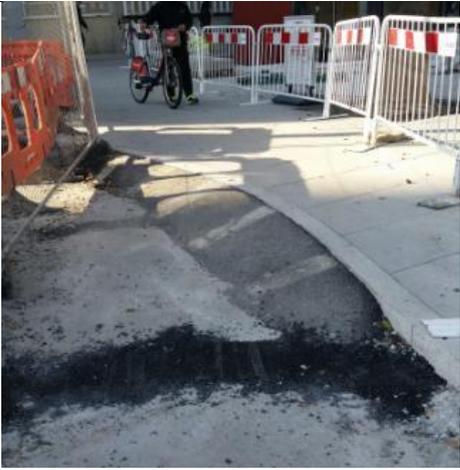
<p>Wheelchair users need level surfaces. Any adverse footway camber is very hard to manoeuvre safely for wheelchair users.</p> <p>Footway “ramps” need to be designed for safe wheelchair usage with no adverse camber in direction of travel.</p> <p>Disabled stakeholders to be invited to comment.</p> <p>Loose gravel to be cleared on footway.</p>	<p>DM to comment</p>
<p>Zone 7. St Georges Circus</p>

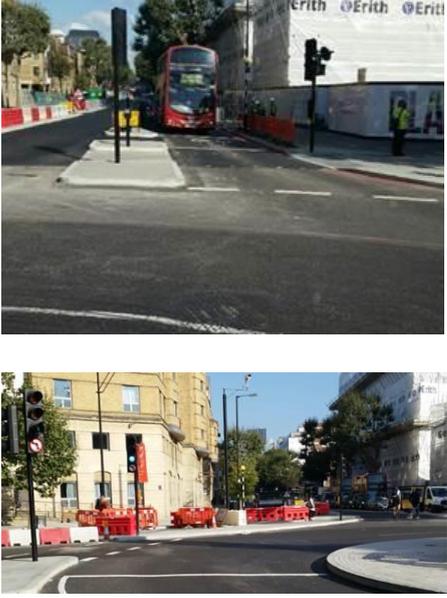
<p>Drivers entering junction assuming it is signaled controlled and do not “give way”, so in conflict with Pedal Mode exiting to Borough Road (from London Road).</p> <p>Blackfriars Bridge Road arm, single dash lines indicates “give way” to roundabout.</p> <p>Southbound and Northbound (from London Road) have green aspect together at staggered junction.</p>	<p>Issued reviewed for safety day of ride, and on the day, installed x2 give way signs on St Georges Circus.</p>

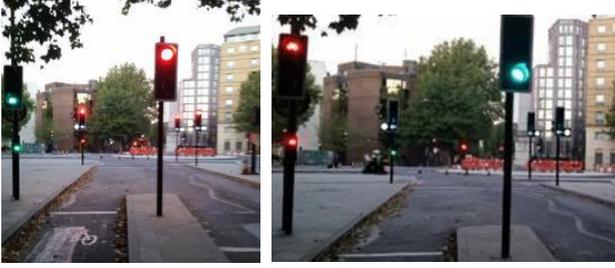
<p>Phasing issue. No “green wave” for pedal mode going straight across the staggered signals, so in conflict with mandatory left turning for general traffic exiting from Borough Road.</p>	<p>PS and TfL teams to comment</p>
Zone 7. St Georges Road

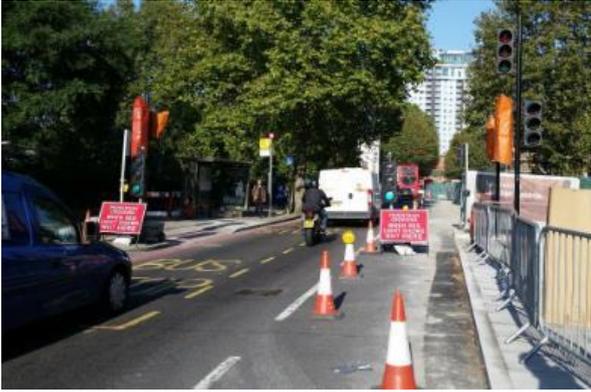
<p>Phasing on crossroads - St George’s Road and Lambeth Road, has insufficient time for the volume of traffic on St George’s Road.</p> <p>No bus stops for months from Elephant and Lambeth North. Is there any chance of a temporary one?</p> <p>Motorbikes and cycles reported to be mounting curb west pavement from around the Prince of Wales pub due to severe congestion. Key route for emergency services impacted by congestion.</p>	<p>MB actioned review following ride to become 2 general lanes. Awaiting response.</p> <p>Enforcement team has been made aware during ride. DM (EoS) to update.</p>

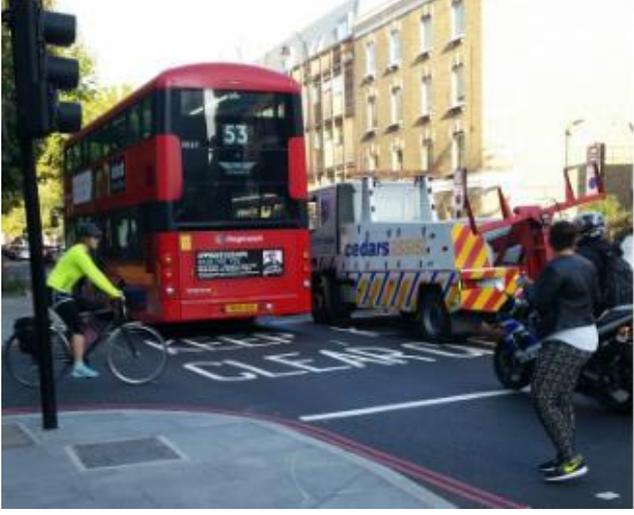
<p>New "keep clear" sign is significant improvement.</p>	<p>Noted. Thanks to PS for swift action</p>
<p>Zone 7. Blackfriars Bridge Road</p>

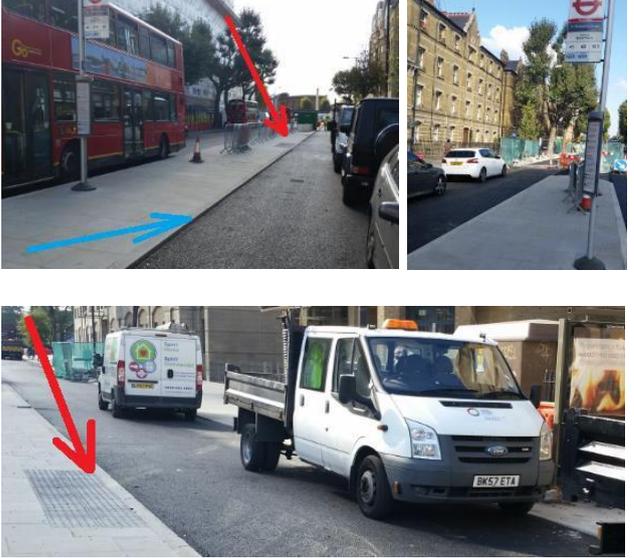
<p>New operational floating bus stop has no "step free" safe access to the main pavement as pedestrian crossing to main pavement is blocked by contractor vehicles.</p>	<p>PS to action.</p>

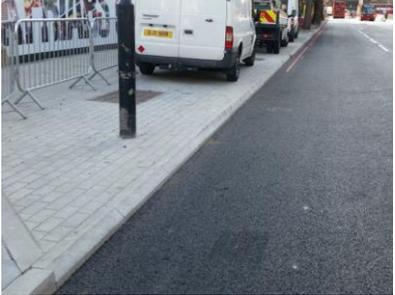
<p>Incomplete red line or yellow line road markings. Or, is this section of road an unrestricted parking area in central London?</p>	<p>PS to comment</p>

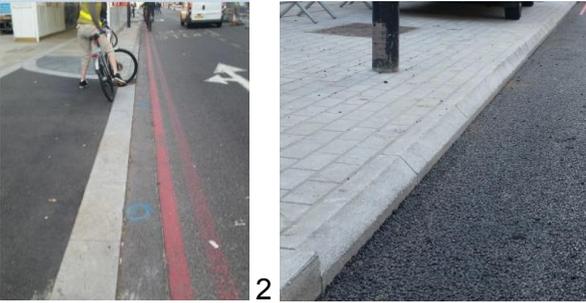
<p>1/ Northbound before Upper Level, side access ~2cm step up off the carriageway. A long longitudinal sheer edge is a trip hazard to many cycles off a busy A road.</p> <p>2/ South end of Blackfriars Bridge Road, raised curb is better delineated as unsuitable for pedal mode to access.</p>	<p>PS to request a strip of temporary tarmac to ramp.</p>
Zone 8 Southwark Road – Redcross Way

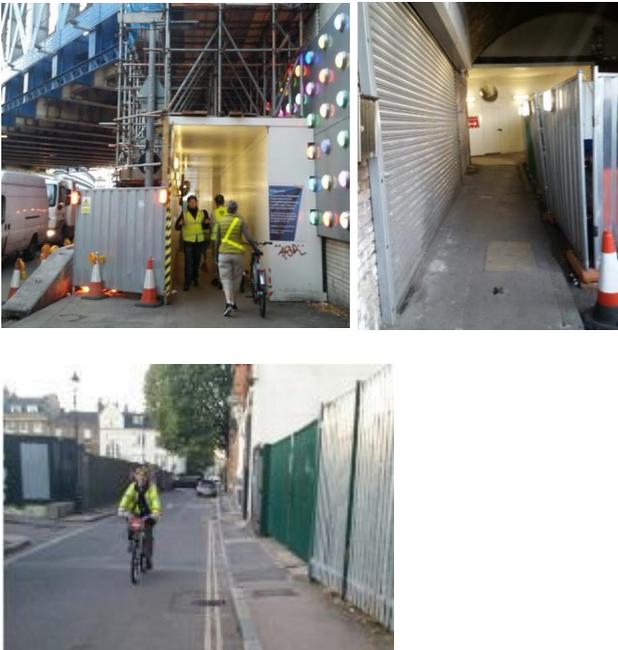
<p>Concern for ambush points on pedestrian exits. No Trixy mirror on exit. No CCTV .</p> <p>Isolated and poorly overlooked side street adds to perceived dangers at night time.</p>	<p>Network Rail site which was previously in worse shape. Intervention from MB and PK lead to brighter colour, lighting and trixi mirrors.</p> <p>Still more could be done to ensure a safe environment. MB to liaise with Network Rail (BW).</p>

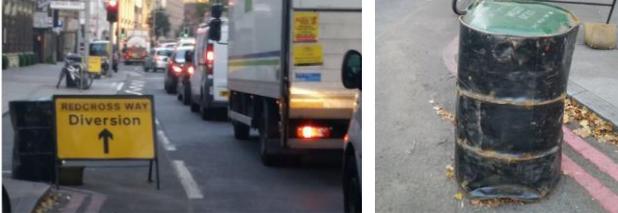
<p>Poorly located sign in road without cones</p> <p>Heavy “oil” drum blocking highway</p>	<p>Signage relocated during ride.</p> <p>Arrangements made to remove contractor’s oil drum during ride by AL.</p>
