Tooley Street	Observations	Actions/Comments

Tooley Street	Observations	Actions/Comments
<p>Cotton Street Crossing</p>

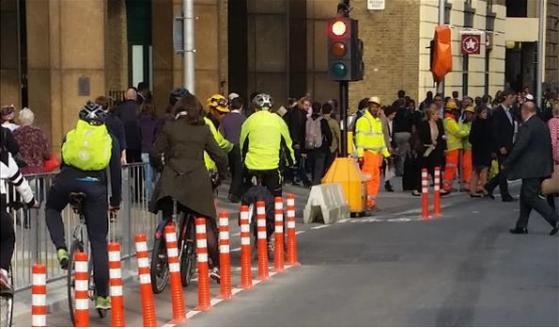
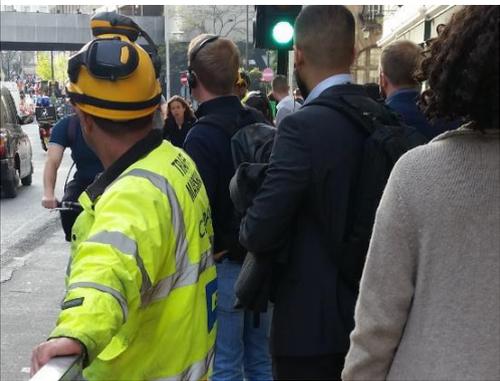
<p>Marshalling seen to be very effective stopping cyclists in advance of the Cotton Lane crossing at the new “SLOW” road marking.</p> <p>This was beneficial to allow crossing to clear of slow moving pedestrians before cyclists released (on Green).</p> <p>Suggest “Stop/Go” sign provided to forward Marshall to support the “red light” or when crossing congested.</p>

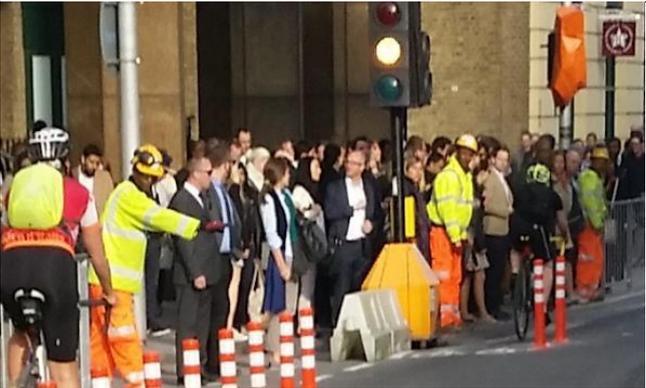
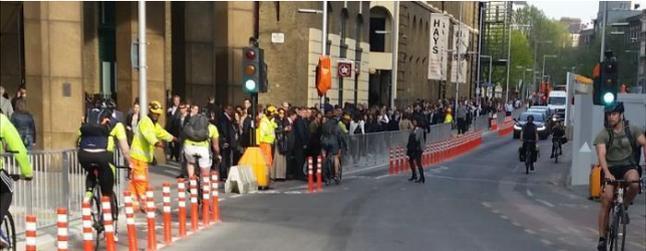
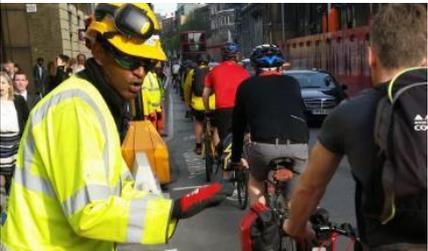
<p>Marshalls seen to be doing an exemplary job at all times, and to be complimented.</p> <p>One marshal “slowing” or “stopping” cyclists in advance of crossing. Two at the crossing (PM peak) to support the “Red Man”. Marshalls regularly pressing “Wait” once lights go Green aspect to reduce pavement crowding.</p> <p>Suggestion: Current layout needs four marshals, with 3 one side, one the other, at busy PM times.</p> <p>Suggestion: Marshals to have whistles to alert other marshals of imminent danger (e.g fast approaching cyclist, or dashing pedestrian)</p>

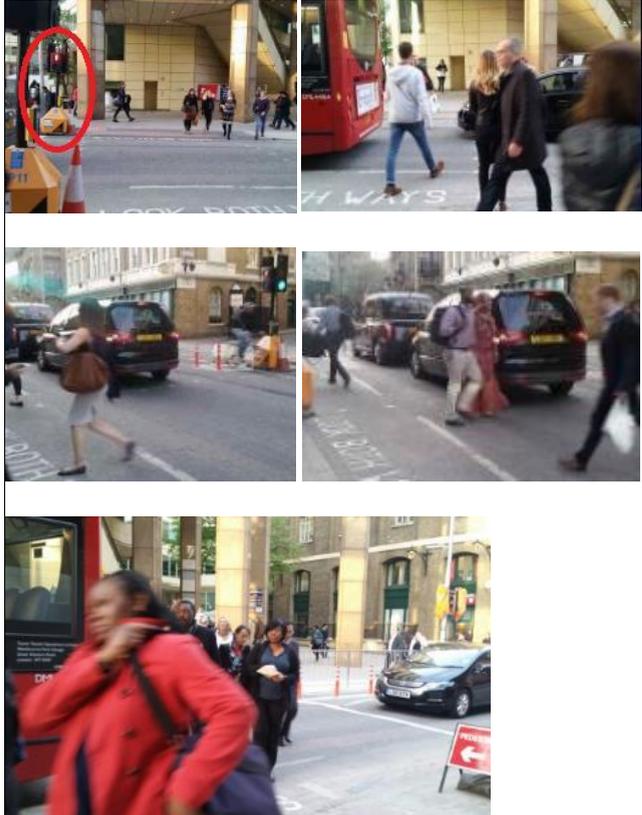
<ul style="list-style-type: none"> • “Red Man” signage often not clearly visible and obscured by traffic (ringed red in photo). • No clear “<i>warning cyclists</i>” signs for pedestrians. • Pedestrians crossing Northbound are at risk of not seeing/appreciating cyclists. <p>Suggestion: Additional traffic pole signal on each side of crossing for “Red Man”, and provide nearside repeater signal low level for “Red Man”, e.g</p>

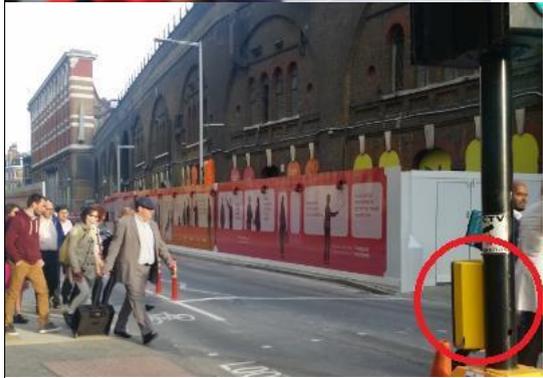
<p>Only one “WAIT” button to press on the wrong side for pedestrian flow/desire line (going to the station).</p> <p>When no Marshalls present, the “WAIT” button was regularly not being used by general public, and meant greater informal crossing incidents seen. Pedestrian sensors ineffective.</p> <p>Suggestion: Additional “WAIT” button/module to be installed on the desire line side of the crossing or sensor located to desire line side.</p>

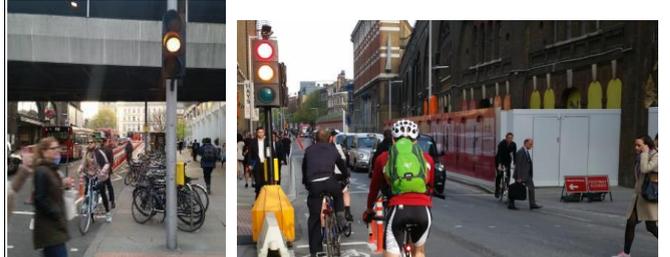
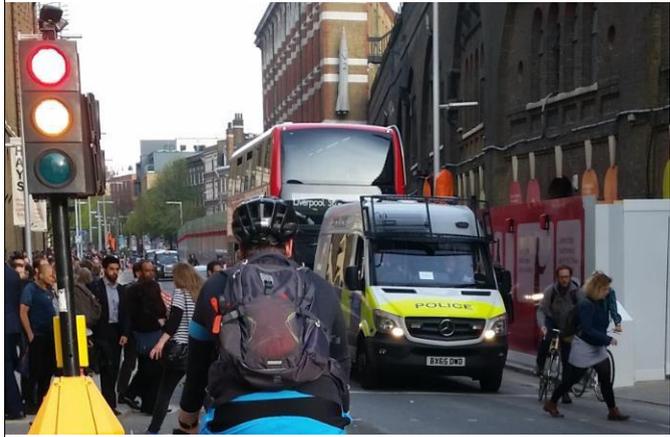
Tooley Street	Observations	Actions/Comments
<p>Pelican Crossing: Puffin Crossing:</p>

<p>Two pedestrians crossing designs not consistent on Tooley Street in function nor phasing.</p> <p>Joiners Street crossing phase (left photo) is Pelican, and about: 11s Red, 50s Green, and goes “beep beep beep”, with yellow flashing signal.</p> <p>Cotton Lane crossing phase is Puffin and is: 20s Red, about 13s Green (if the WAIT is pressed)</p> <p><i>“Puffins do not have a flashing green man for pedestrians or a flashing amber for drivers.”</i></p> <p>Suggest the Joiners Street Crossing revised to have same timing phase as Cotton lane. This will mean more cyclists become bunched up, and slower on approach to Cotton Lane.</p> <p>Suggest Cotton Lane crossing has flashing Amber stage and beeps.</p>

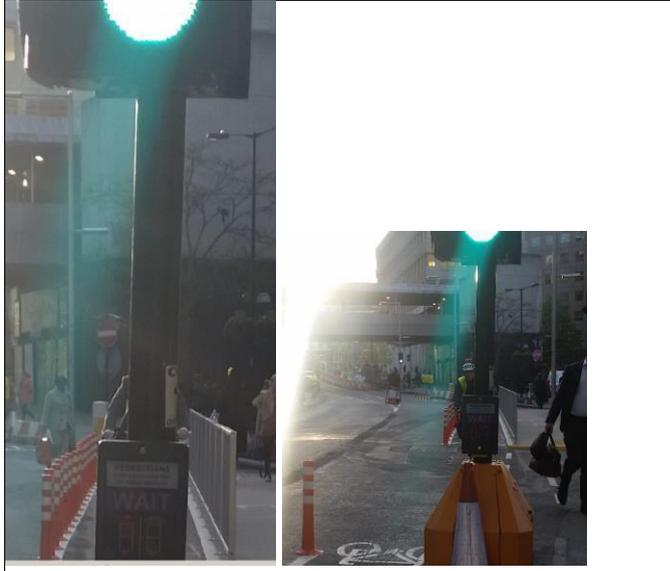
<p>Cotton Lane traffic signal location obscures seeing cycle track (for Eastbound cyclists).</p> <p>The “red and green figures above the control box” appears not to be working. See photo left.</p> <p>Cycle track to be made more visible. Suggest paint blue.</p>

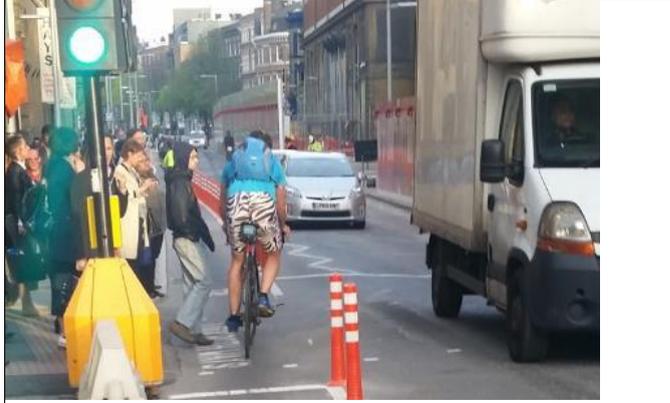
<p>Collisions and near misses being seen.</p> <p>When cyclists swerve out of the way of pedestrians, high risk of hitting wand on opposite side of crossing, or forced into oncoming traffic.</p>

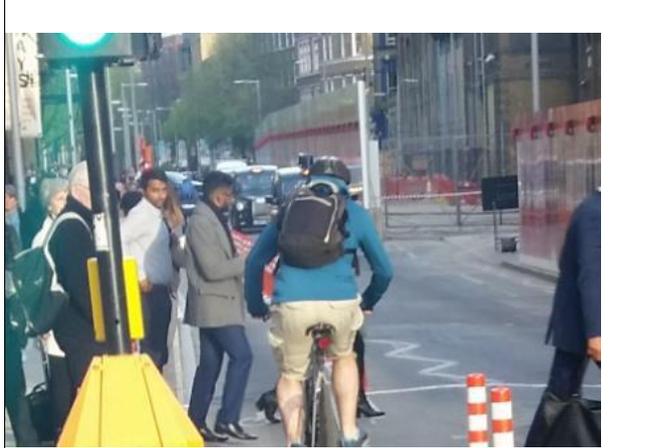
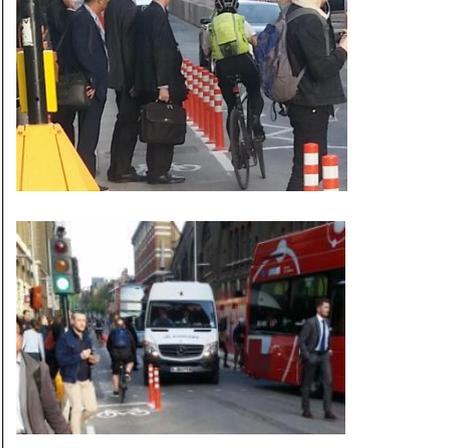
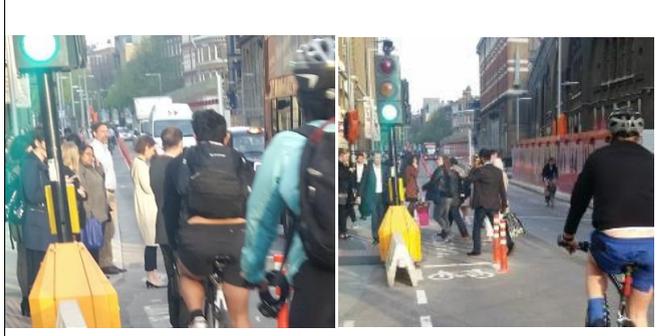
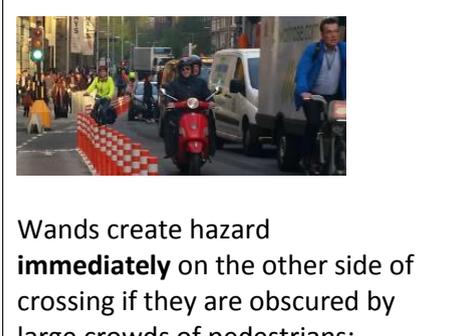
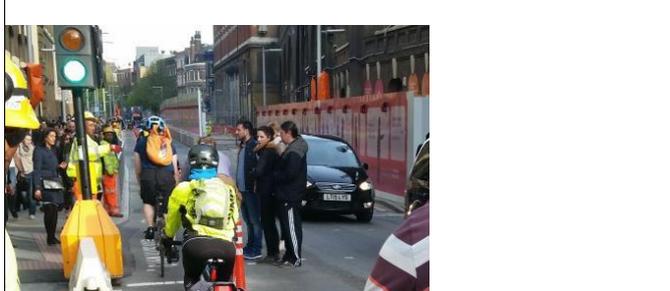
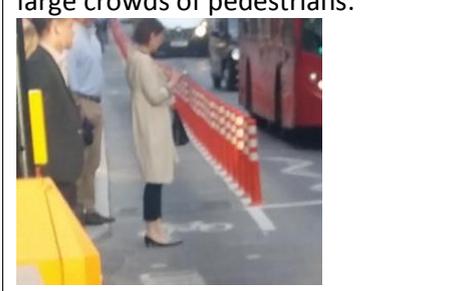
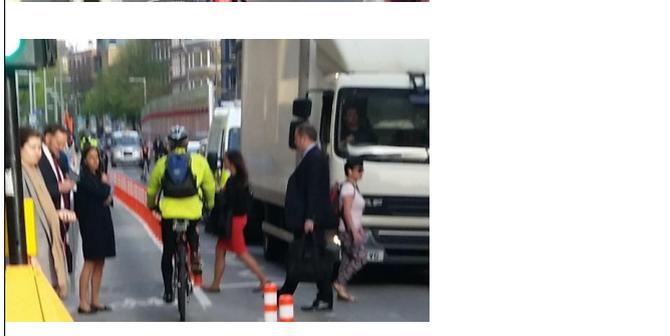
<p>Wands create hazard immediately on the other side of crossing if they are obscured by large crowds of pedestrians:</p>

<p>Suggestion. Remove some wands after crossing and replace with white hatched safety area on highway that indicates starts of first wand, and to better keep Westbound traffic in the correct path and provide safety zone for pedestrians.</p>

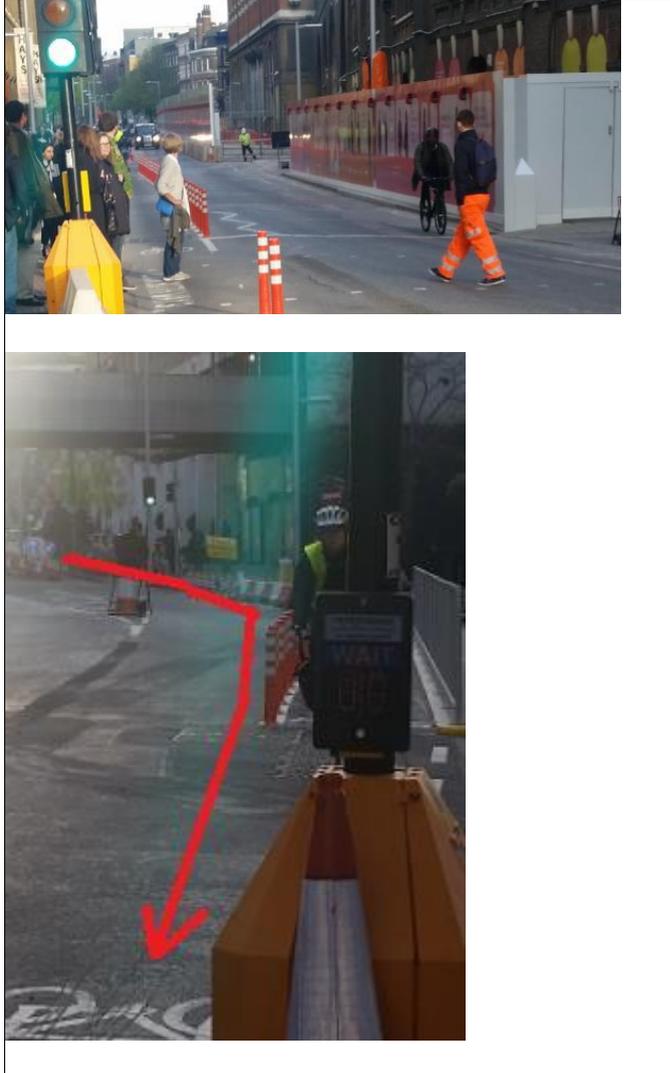
<p>Pedestrians regularly seen not to be looking at “Red Man” nor looking at cycle track after starting to cross.</p> <p>A pedestrian crossing can take ~6 seconds. In the same 6 seconds many cyclists can travel from Joiners Street to this crossing (<i>red arrow</i>) and surprise pedestrians on crossing.</p> <p>Cyclists at speed due to downhill approach.</p>

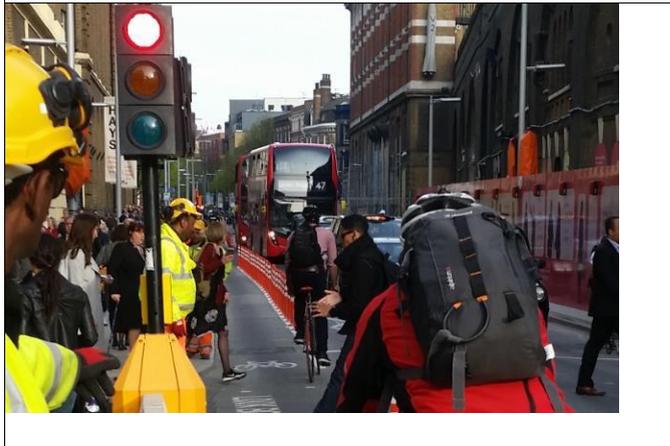
<p>Met Police required to enforce cyclists jumping red lights deliberately.</p>

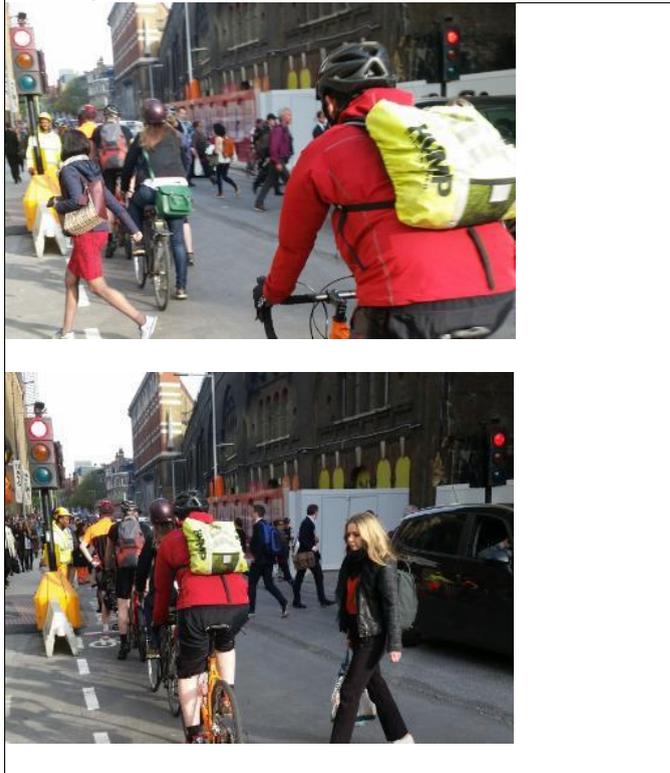
<p>High levels of pedestrian overspill outside of crossing area.</p> <p>Crossing threshold is poorly identified.</p>

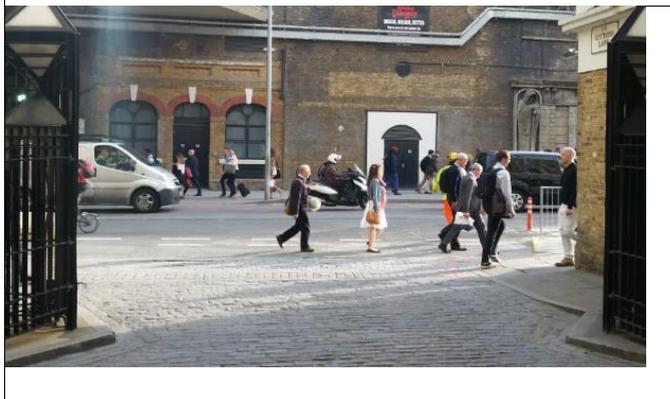
<p>Vehicles exiting Cotton Lane, needs clearer "Right Arrow" on lamp -post opposite.</p> <p>P2W seen tried to turn left into cycle track.</p>

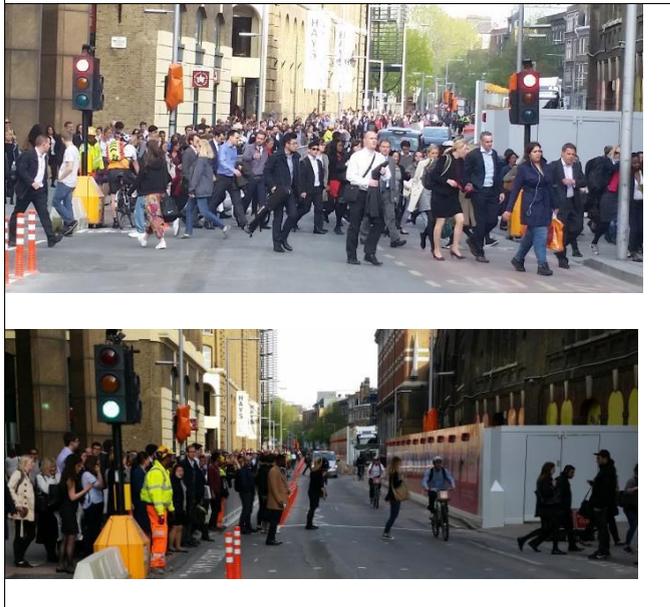
<p>5-6000 pedestrians/hour and difficult to control at busy times.</p>

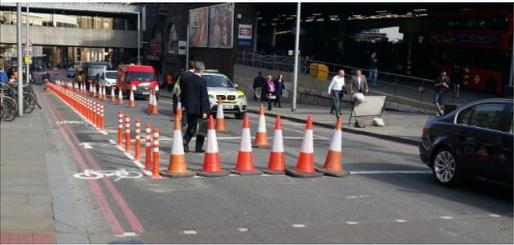
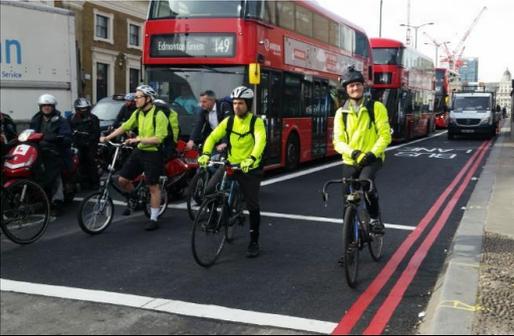
<p>Bus lane installed is welcome improvement.</p> <p>New coned exit to Tooley Street measure appears to be working well. But often gets congested as Southbound vehicles (off London Bridge) regularly block Tooley Street traffic.</p>

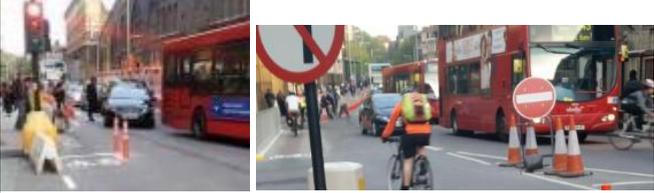
<p>Westbound road flares wider passed Cotton Lane crossing, then has pinch point with "No Entry" coned area.</p> <p>Suggestion: Could this be better marked out?</p>
