FOCUS ON BISHOPSGATE DEVELOPMENTS

Roadworks Patrol – 7TH July 2017

Bishopsgate, City of London	Observations & Suggestions (TfL),
100 Bishopsgate

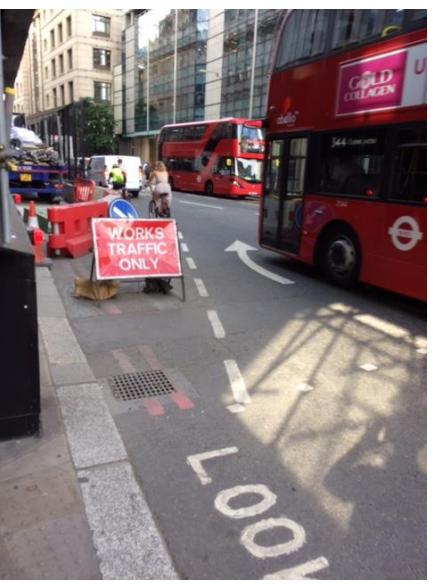
<p>Works signage has been placed in the cycle lane taper.</p> <p>Relocate signage to an appropriate position</p>

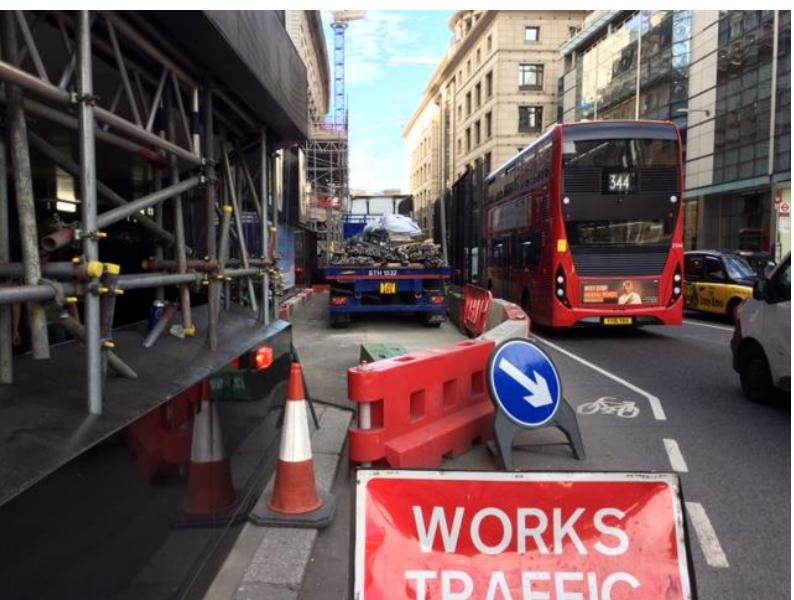
<p>There were no “Narrow Lanes, No Overtaking Cyclists” signs visible.</p> <p>Investigate opportunities to place signage that warn drivers of reduced lane widths.</p>

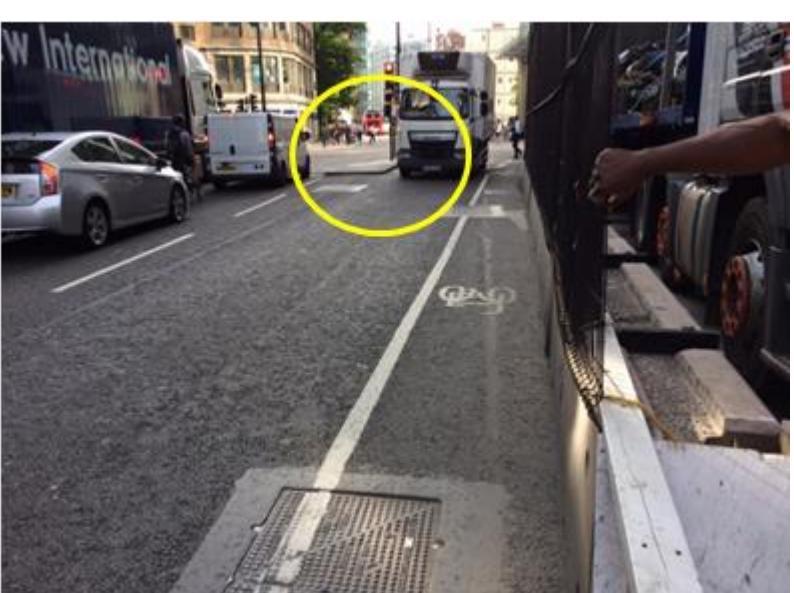
<p>Mandatory cycle lane in place but substandard (have or not to have). Visible pinch point where loading area starts and position of traffic island.</p> <p>Barrier fence is flush to concrete barriers (VCB) and hazard for handlebars (VCB)</p> <p>Check how long loading area required then investigate opportunity to trim island (yellow circle).</p> <p>Driver safety is a priority and TfL is aware of the HSE concerns when exiting vehicle. There maybe an alternative fence that minimises conflict, To be investigated.</p>

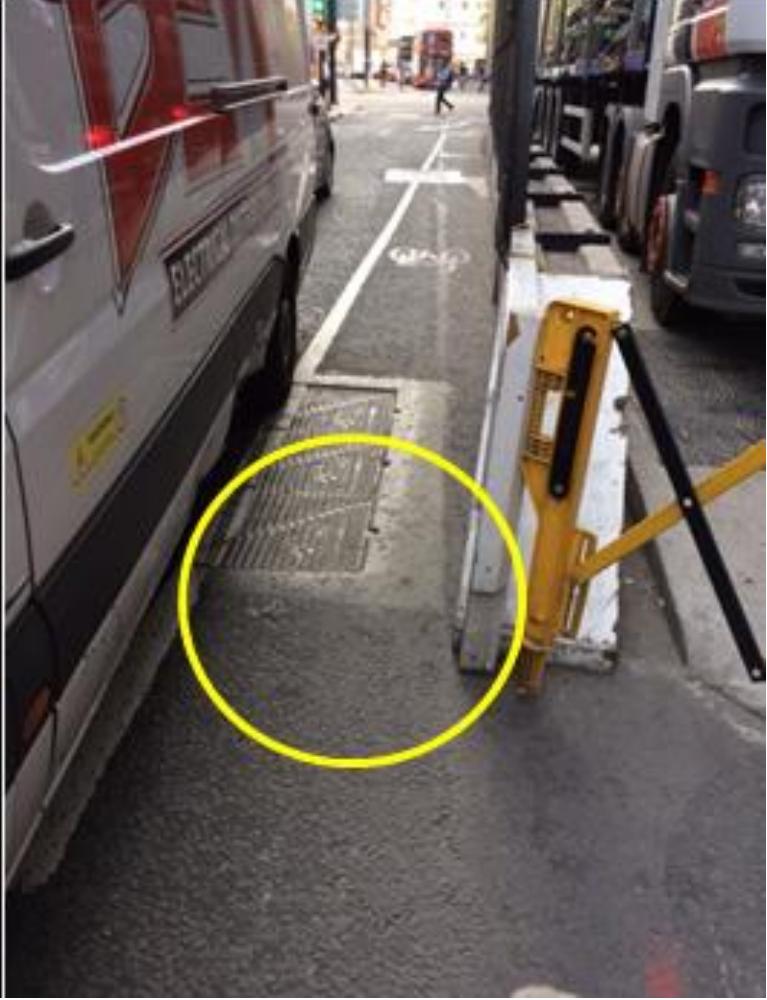
<p>End VCB has been pushed out causing another pinch point within the cycle lane.</p> <p>MB discussed with marshals who said lorries were clipping the VCB on exit hence moved out. MB questioned why site had not informed TfL of the issue?</p> <p>Investigate option to remove VCB and replace with plastic barrier that will have less width and wont damage vehicles during vehicle manoeuvres.</p>

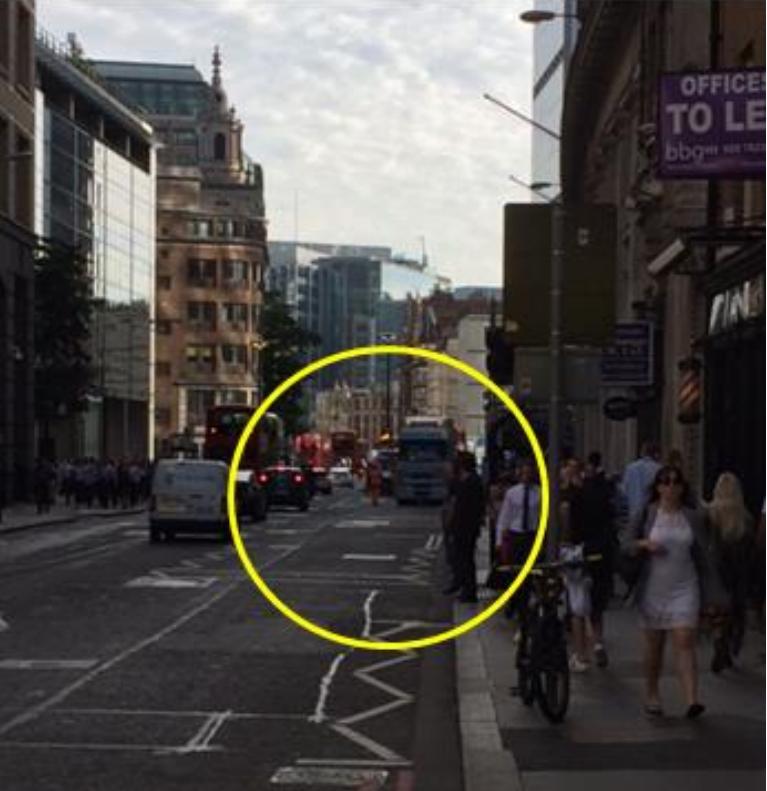
<p>Vehicle observed reversing into loading area. OB confirmed this was not an agreed method. This held up traffic heading southbound and blocked back to the junction</p> <p>MB asked marshals why they reversed and reply was difficulty in accessing loading area. OB was not aware of any reports being supplied to TfL of this issue.</p> <p>Discussions are required to take place with contractor to revisit logistic methods.</p>

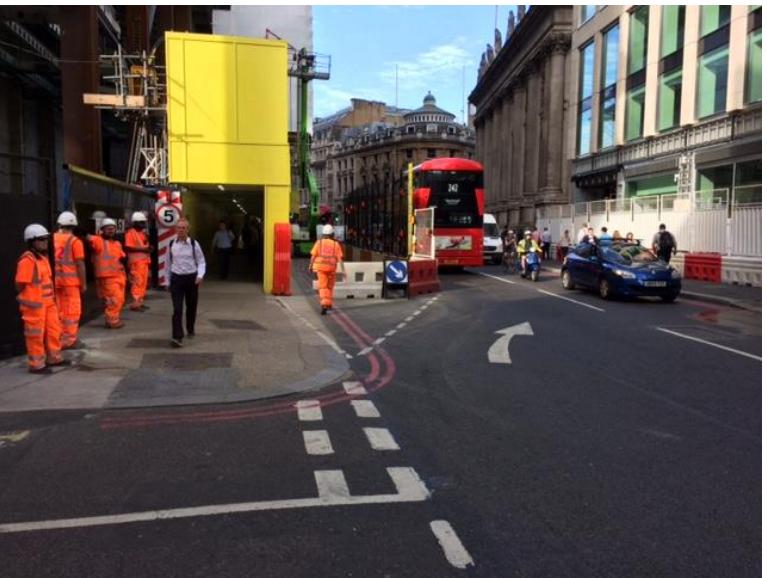
<p>Remaining road widths adjacent to the loading facility narrow causing a pinch point.</p> <p>No cycle facility at this site and no warnings of narrow lanes.</p> <p>Investigate opportunities to place signage that warn drivers of reduced lane widths.</p>

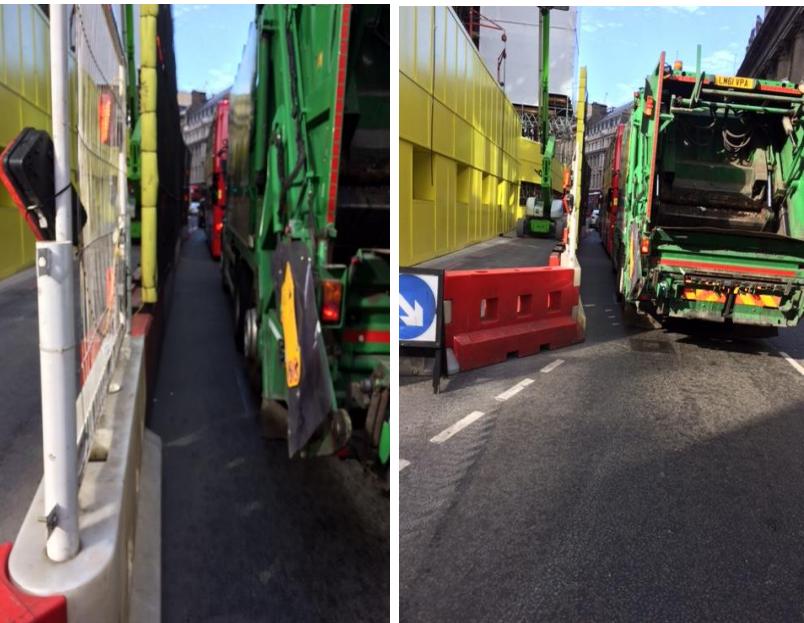
<p>Almost zero width for cycling thoroughfare and many cyclists observed overtaking between opposing flows of traffic.</p>

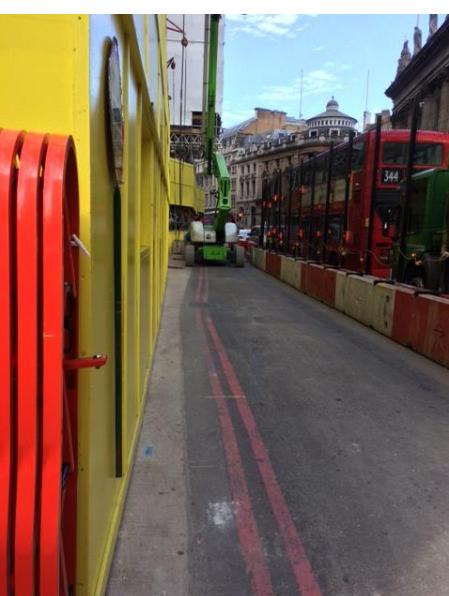
<p>Loading area empty during visit.</p> <p>Question to be asked on frequency of use. If low and during off peak could be open for when cycle flows are high.</p>
