FOCUS ON TIDEWAY CYCLING MITIGATION

Roadworks Patrol – 19TH June 2017

A focus on the Tideway Scheme

Observations & Recommendations (TfL), Tideway response(TW)

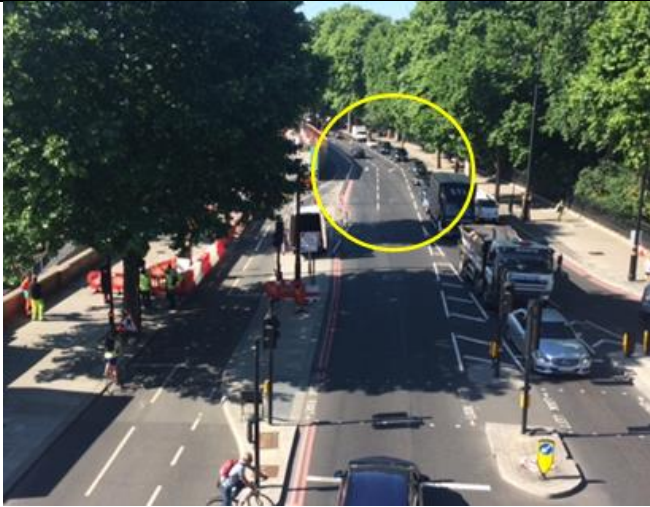
Advisory center line markings between opposing traffic lanes. Motorcycles observed filtering outside lane 2 westbound towards opposing traffic. As lane widths are at a minimum this raises safety concerns.

Enhance area with double white lines (including studs as per Police request) to reduce these manoeuvres.

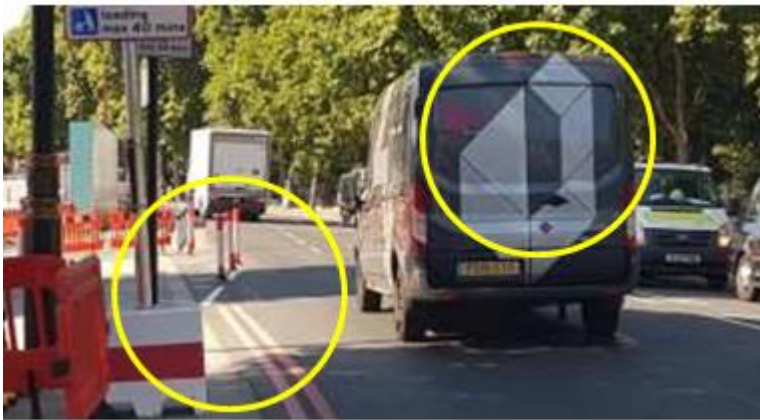
Vehicles observed straddling lane 1 and lane 2 advisory markings (westbound) due to deflection markings by the lorry holding bay.

Extend chevrons where short stub is located to deflect vehicles earlier, reduce advisory markings and give clear indication for which lane vehicles should be in.

Tideway consultant to advise on design

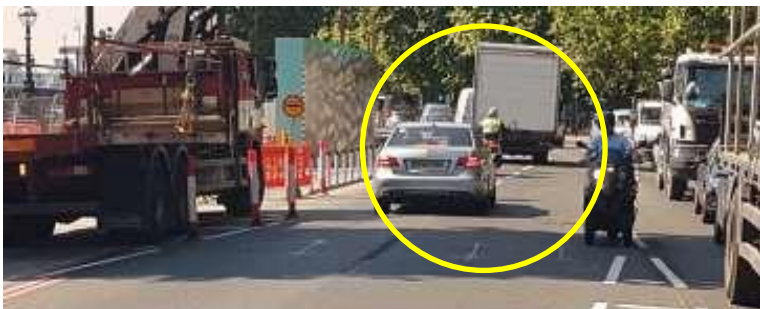
Low level signals for cyclists only faced one direction with some cyclists observed entering the main carriageway potentially due to not seeing signals.

This has now been rectified

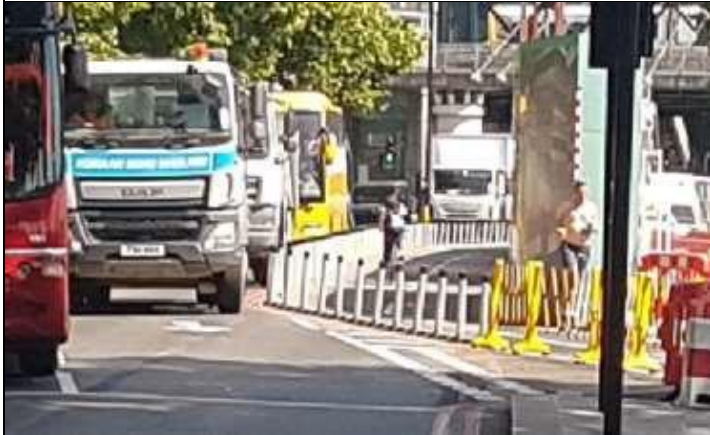
Road cyclists/mopeds at risk at pinch point. Insufficient warning of narrow lanes ahead

Suggest general traffic “Narrow Lanes Ahead” warning and 20mph speed restriction.

Tideway to review with TfL

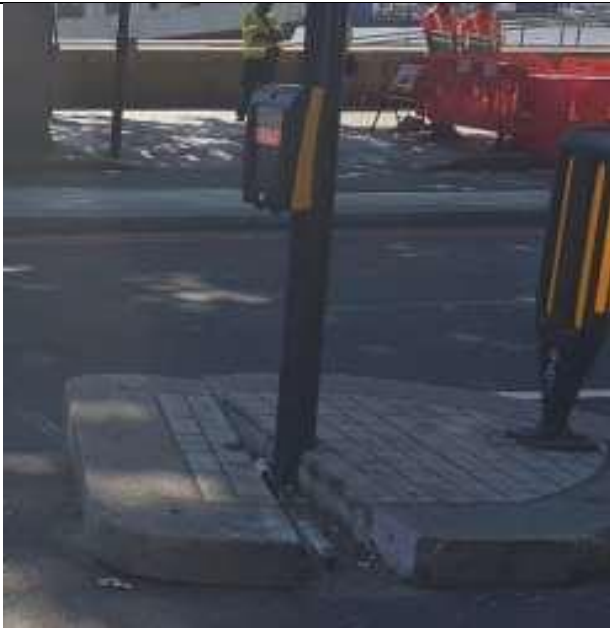
Demountable island out of alignment and requires resetting.

Report has been submitted to Highway Authority

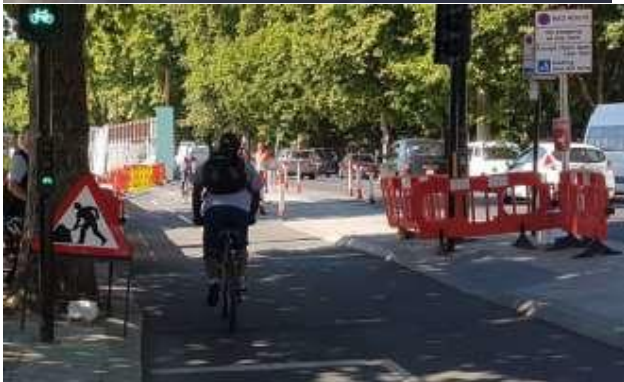
Pedestrians now diverted to northern footway due to footway closure. Existing crossing facility will now have an increase in pedestrian activity. Trees and traffic management obscure vision for pedestrians and cyclists.

Suggest investigate methods to enhance the crossing areas eg raised crossing area and/or coloured surfacing and warning text (look both ways).

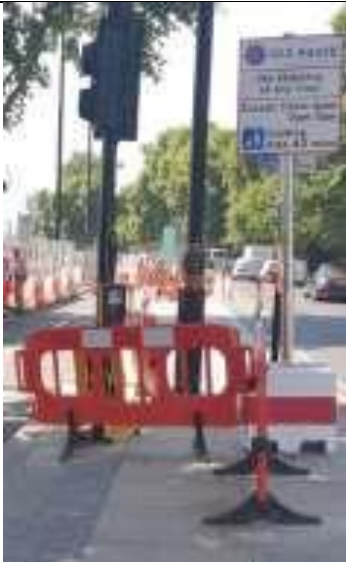
Central island push buttons obstructed by traffic management

Relocated on the day

Tideway to constantly monitor site and review existing layout and temporary design

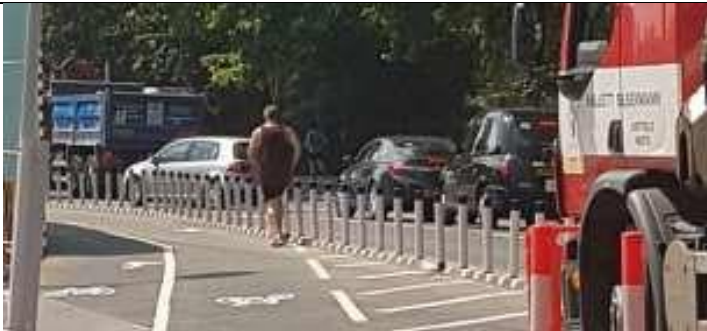
'Cycle speeds were frequently observed being high along this stretch of track.'

This raised safety concerns due to Joggers and pedestrians using the track instead of following the diversion.

Some riders found the hoarding design was visually disorientating.

Tideway to review placement of "slow" markings on the surface and use of the hoarding on approaches.

Tideway to review and monitor for further reports

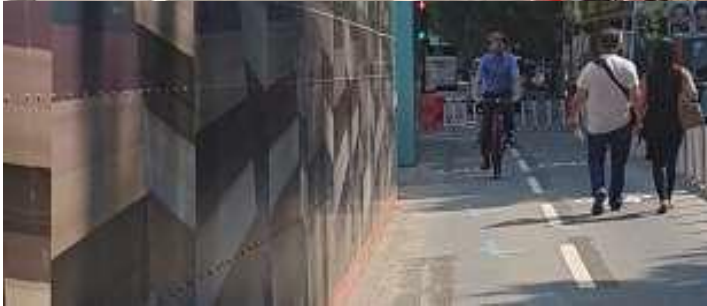
Lots of tourists use this part of the embankment and were often observed being confused on which direction to travel and frequently crossing without looking.

Pedestrian desire lines raised concerns for their safety as risks are being taken (this tends to be the norm across London but raised due to the increase in multiple conflicts with site activities).

Suggest way-finding be revisited to ensure sufficient signage is in place and divert pedestrians earlier to disperse some of the numbers.

Tideway to review all diversion signage and way finding. Also to investigate early diversions

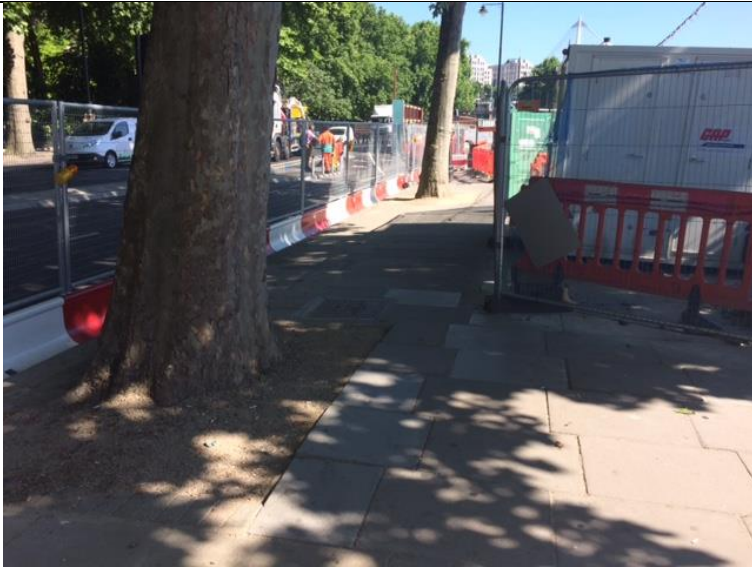
Pedestrians may be enticed to wander passed the closure points which leads to security concerns for all parties especially during the night.

Suggest more robust traffic management and liaison with the moored party boats for a collaborative approach on security.

Tideway to investigate section 17 mitigation measures with TfL and Police.

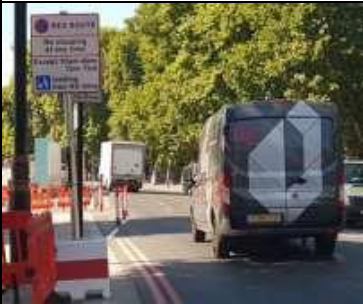
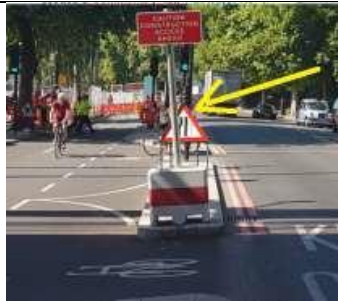
Loading signs may invite other vehicle to use holding area.

Suggest removing and replace with authorized vehicles only.

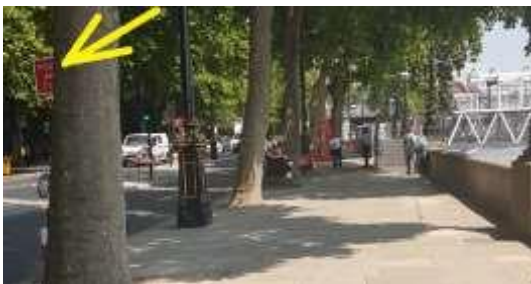
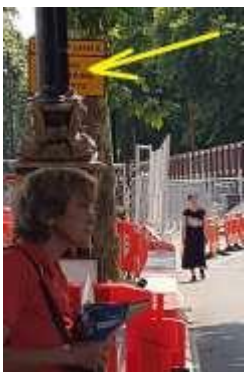
Many of the temporary signs were placed so that vision was obscured

Sign stated "Narrow lanes, no overtaking cyclists"

Suggest removing sign to avoid confusion.

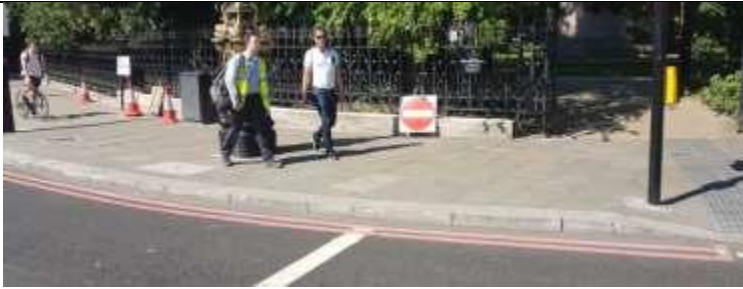
Met Police signage has been left in footway giving misleading messages.

Requires relocation away from site

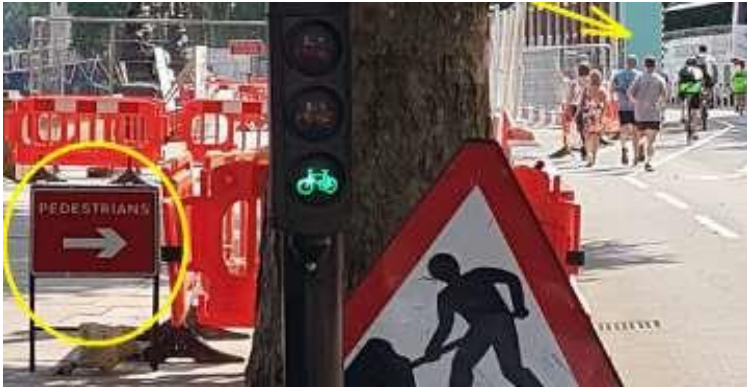
Existing signage may be unclear to pedestrians hence using cycle track for thoroughfare. Eg use alternative below:

Tideway to review all signage locations, signs used and the message being put across.

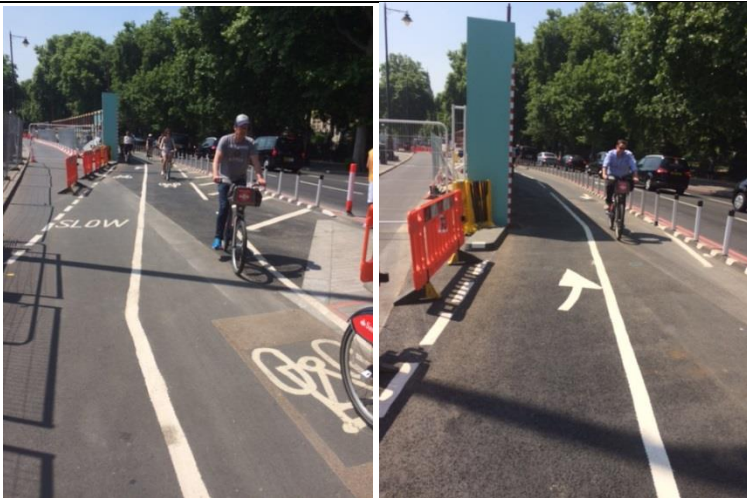
Sharp lining and visibility splays were affecting riding comfort.

Suggest smoothing of lining be investigated and reline centre line markings (advisory at present along the hoarding) with a solid line to discourage overtaking.

All hoardings should have lighting on the side

Tideway to review all line markings and hoarding lighting.

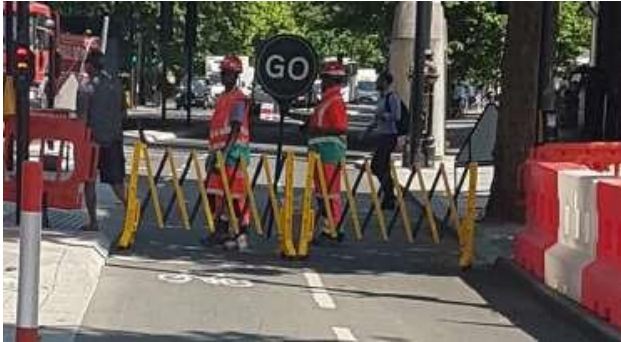
Marshals observed using two attached concertina barriers which often came undone.

As originally discussed, to use one robust barrier system

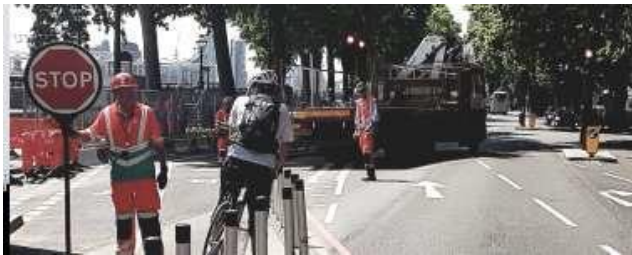
Stop works signs to be used at both ends (the correct and legal sign)

Tideway will ensure correct signs used

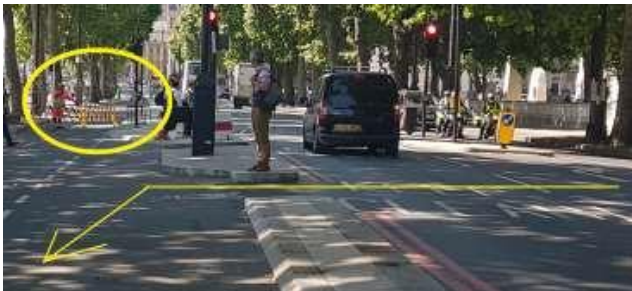
Barrier placement missed the cycle route from Horse Guards Avenue.

Suggest revising location

Tideway stated marshal was in the wrong location which will be reiterated during toolbox talks.

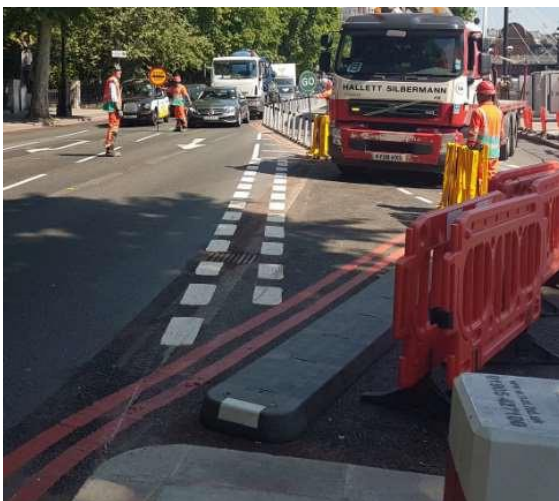
Lack of visibility for vehicles in queue of marshals in the carriageway plus facing away from traffic a serious safety concern.

Suggest investigating safer methods and increase practice runs to improve efficiency.

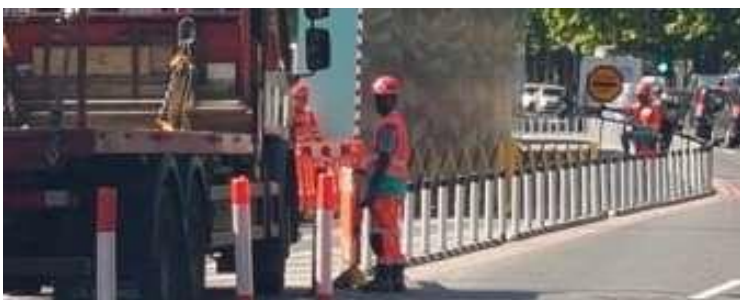
Marshals need to pay more attention to their own safety when around the site. Often observed walking in the road, across the tracks without looking first.

Tideway to review and cover in toolbox talks

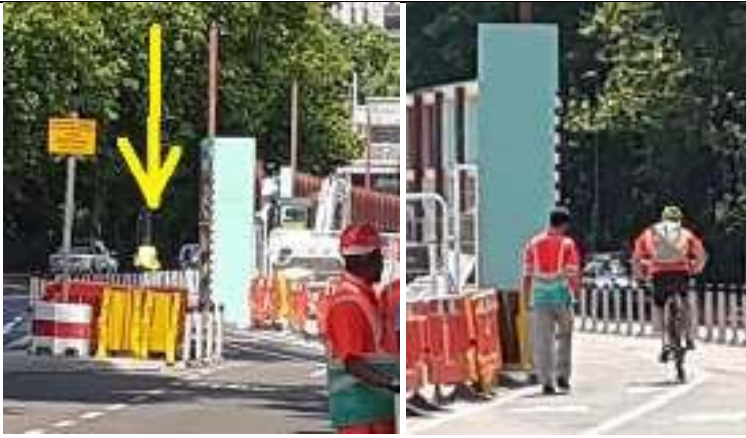
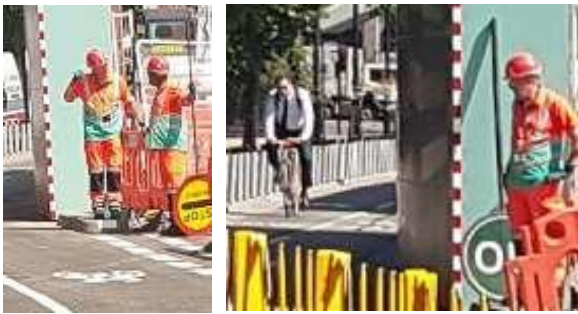
Visibility of marshals by approaching cyclists affected by hoarding line.

Suggest look at alternate measures to enhance awareness of activity points. Eg surface dressing or mosquito flags.

Also use of whistles to raise awareness of activities

Tideway to review all methods and safety risk to staff

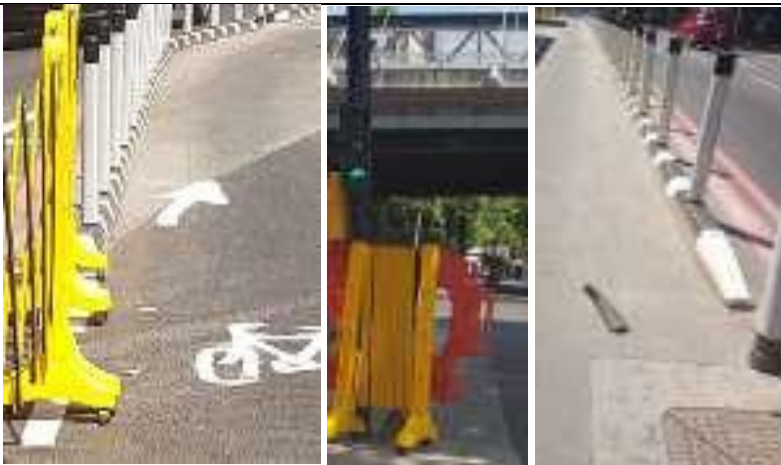
Barrier creep or sliding risk into cycle track and debris observed in the tracks.

Suggest regular maintenance sweeps 3 x daily

Use of robust concertinas in addition clipped to solid objects to avoid movement to be reviewed.
