Southwark, Lambeth and Wandsworth

Cycling and Traffic Management Partnership – 18 November 2015 (7.30

AM ride) Authors: Michael Barratt TfL and Francis Bernstein Southwark

**Minutes**

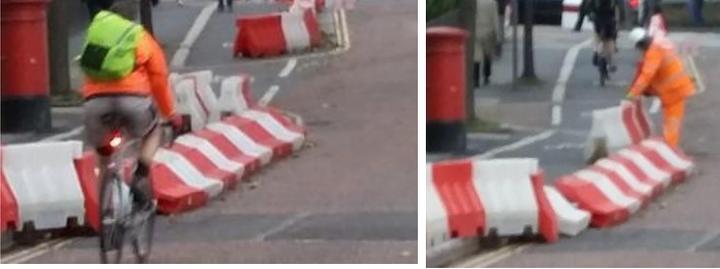
<p>Barriers not being maintained safe, and moving into road. Issue raised in the 30th Sep 2015 Cycle Ride, yet these "water filled" barriers are still not water filled.</p> <p>Alert to all PMs to check barriers are installed and anchored correctly.</p>	<p>Acted on same day by TfI (MB)</p>

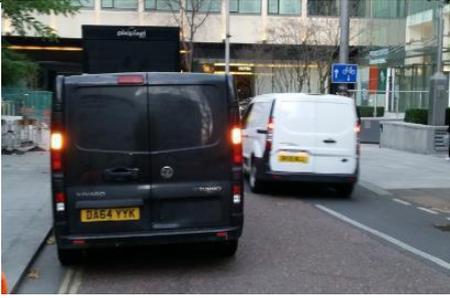
<p>Delivery and Contractor vehicles repeatedly blocking road, forcing other vehicles to cross into contra-flow cycle lane.</p>	<p>Parking zone to be implemented shortly by Southwark</p>

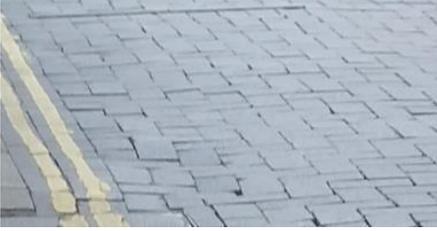
<p>Blocks uneven and causing trip hazard to pedestrians and danger to cyclists. Sets condition worsening rapidly. To be escalated to Lambeth Council.</p>	<p>MB to inform SBEG and Lambeth (2<sup>nd</sup> time)</p>

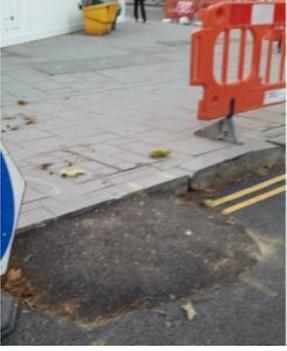
<p>Crossing to London Eye dangerous and unsuitable for wheelchair users.</p> <p>To be escalated to Lambeth Council.</p>	<p>MB to inform Lambeth</p>
<p><b>Zone 3. Vauxhall</b></p>

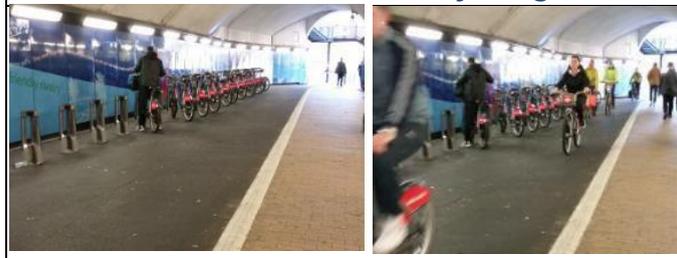
<p>“One way” cycle track not clearly marked for tourist collecting cycle hire.</p> <p>Suggest cycle logos on CSH and other signage.</p>	<p>MB to forward comments</p>

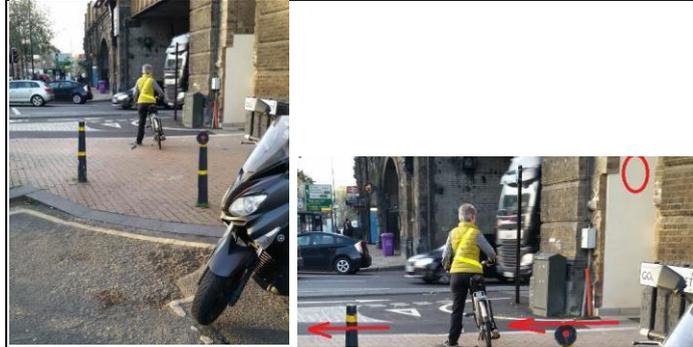
<p>Cyclists from Goding Street and estates, cross southbound CSH at a blind narrow exit from the tunnel.</p> <p>Suggest</p> <ul style="list-style-type: none"> <li>• Trixi (indicated).</li> <li>• No Entry sign.</li> <li>• Painted cycle logos on CSH indicating direction.</li> </ul>	<p>MB to inform sponsor</p>
<p><b>Zone 3. Wandsworth Road</b></p>

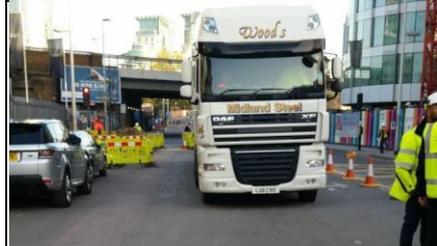
<p>HGVs incorrectly parked in areas not approved for waiting.</p>	<p>Acted on same day by TfI (MB)</p>

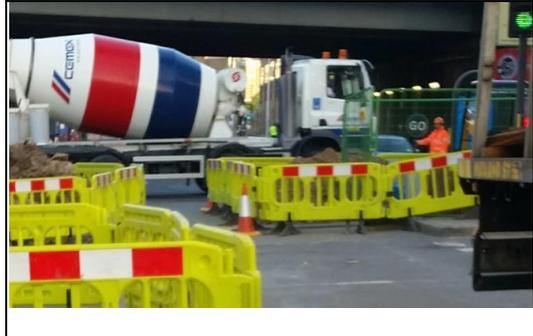
<p>Manual "Stop/Go" signs (for deliveries reversing into works) causing danger to contra flow cyclists.</p> <p>Sign to approach cycles needs to be "Stop"</p>	<p>Developer to ensure robust marshalling is in place.</p>

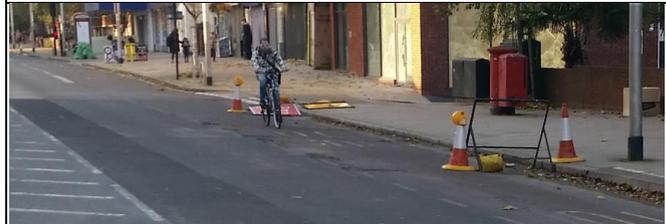
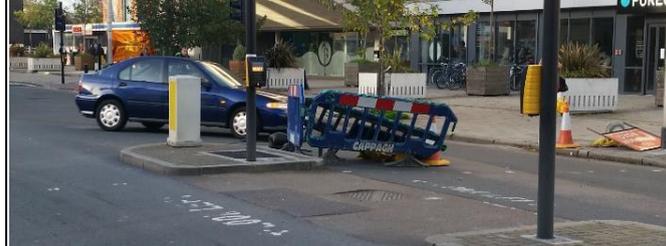
<p>TM "Road Closed" and "Diversion" signage not maintained and left fallen down.</p> <p>Lambeth and Contractors unreliable and unsafe in their TM management for the diversion and road closure signage.</p>	<p>Developer to be asked to ensure maintenance checks are in place.</p>

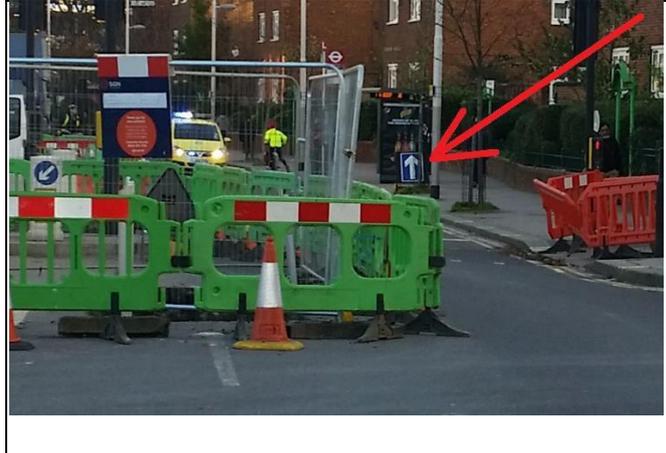
<p>No "No Entry Signs" at road two-way closure.</p> <p>TM "one way" sign not being maintained. This sign placed the wrong way round, adding to confusion to cyclists.</p>	<p>Acted on same day by TfL (MB)</p>

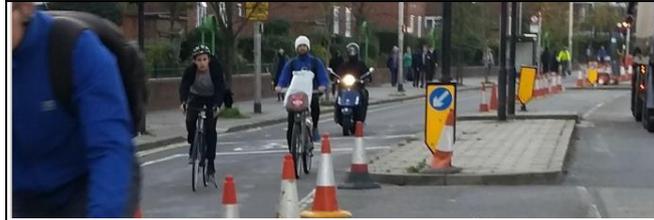
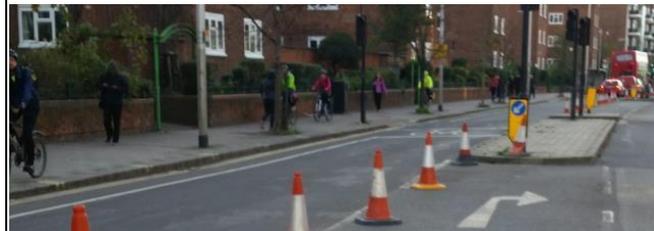
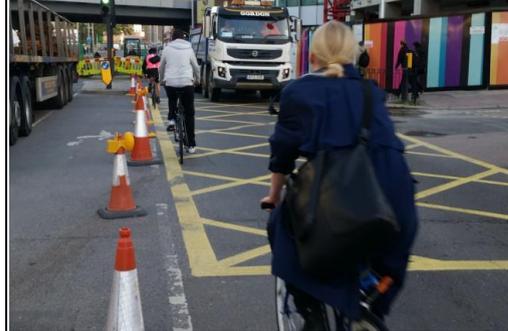
<p>Cyclists and P2W peak and off peak cycling via road and pavement to avoid long diversion. Situation being monitored, and seen to be worsening week on week with cyclists in conflict with HGVs, buses and emergency vehicles moving at speed on one-way section. Large vehicles suddenly swerving to contra-flowing cyclists and P2W.</p> <p>TfL priority to get safe two way cycle route through works.</p>	<p>MB supplied new design to Lambeth which has now been implemented to allow cyclists to maintain northbound direction.</p>

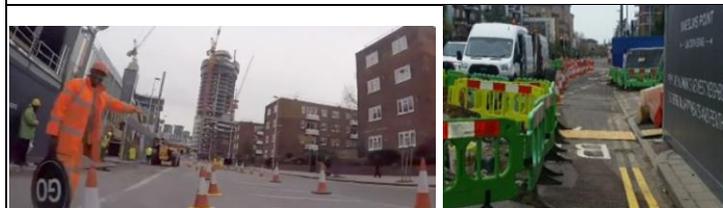
<p>Revised scheme for cycle track Northbound implemented same week, after detailed discussions with multiple site contractors and utility services.</p>	<p>POST RIDE UPDATE</p>
<p><b>Zone 4. Oval</b></p>

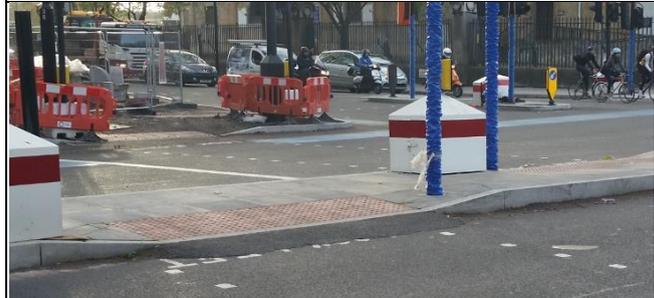
<p>Kennington Park Road:</p> <p>PM to provide scale drawing for wheelchair space over island crossing.</p> <p>Can a wheelchair or mobility chair safely turn on a flat surface (and not an adverse camber) and navigate the pinch point?</p>	<p>Sponsor team to be consulted</p>

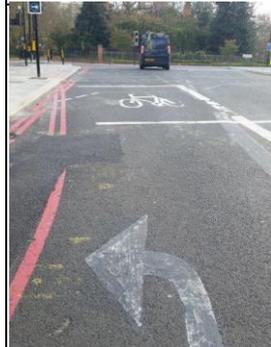
<p>At the "right only" junction (southbound Kennington Road), the black paint on the old "left filter" arrow has rubbed off.</p> <p>Some cars being reported turning left at junction.</p>	<p>MB to report to PM</p>

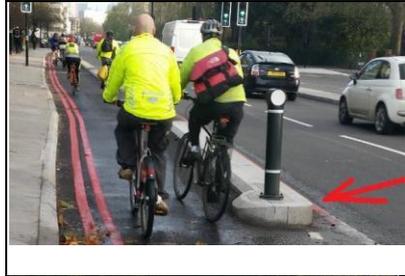
<p><b>Kennington Park Road</b> Why is narrow pinch point being left, on entrance to CSH?</p>	<p>Sponsor team to be consulted</p>

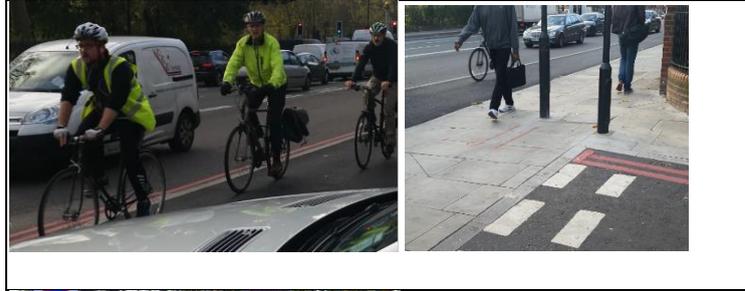
<p>Junction with Magee Street. Vehicles restricted view from "give way". Complaints from car drivers regarding safety of layout.</p>	<p>Sponsor team to be consulted</p>

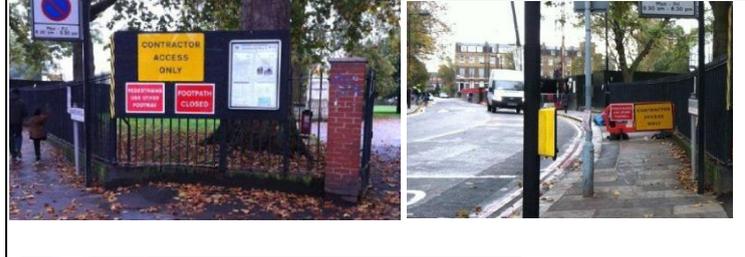
<p>Prompt action taken by TfL to improve signage at the entrance to Kennington Park. Original signage (see left pic) suggested that that entrance to the park was closed.</p>	<p>MB has informed NLE PM</p>

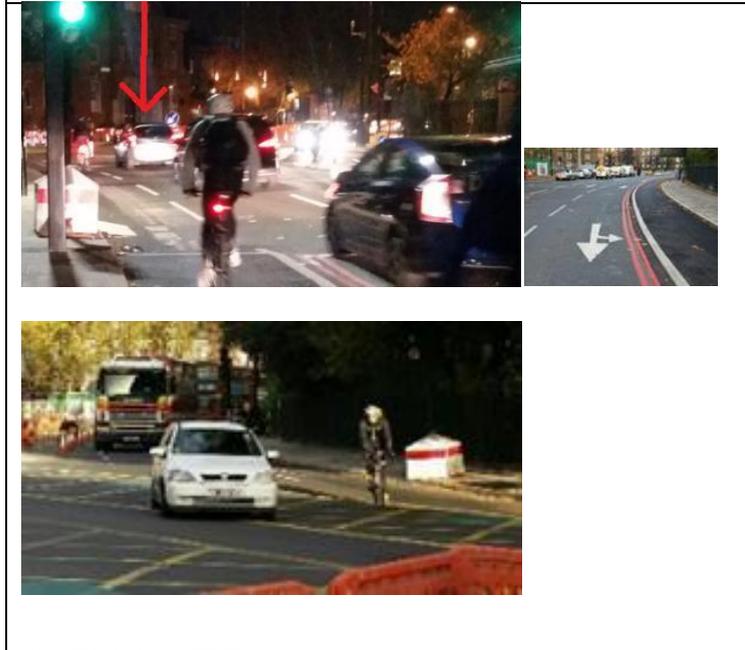
<p><b>Brixton Road Southbound</b> Cycle track "merges" with traffic turning left. No warning signage of temporary TM layout.</p> <p>Cars turning left across cyclists, creating "left hook" danger.</p> <p>Red arrow is junction exit for "straight over". Cyclists and vehicles now seen indicating "right" to go straight over junction.</p> <p>Issue raised in TfL meeting 13/11/2015, but no improvements seen on ride.</p>	<p>MB has informed sponsor. Meeting with design team to look at issues arranged.</p>

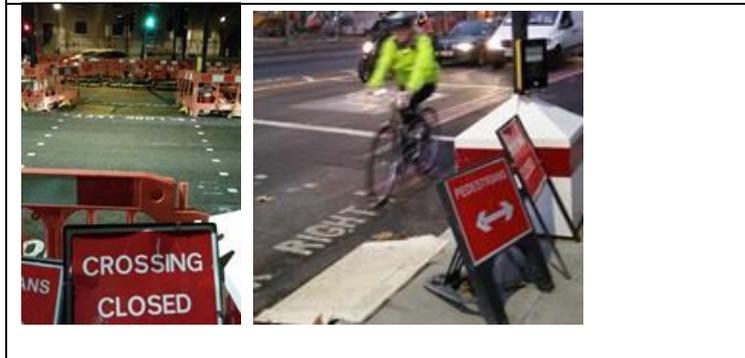
<p>Pedestrian ramp not required with crossing closed. Ramp blocking cyclists leaving the raised segregated cycle track. Pedestrian "green man" still working, yet crossing being closed.</p>	<p>MB to inform PM</p>
<p><b>Zone 6. Elephant &amp; Castle Working Group – St Georges Rd</b></p>

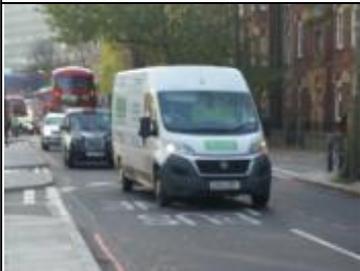
<p>Old "bus lane" markings must be blacked.</p> <p>Vehicles seen swerving into nearside, or holding up traffic to move in.</p>	<p>PS to action awaiting update.</p>
<b>Zone 7. Blackfriars Road</b>

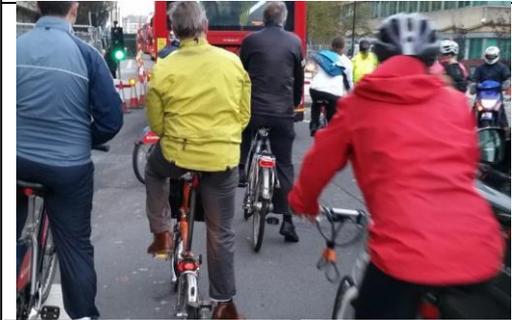
<p>Heras fencing banners flapping loose in the winds.</p> <p>Narrow lanes causing frustration to cyclists.</p> <p>Side roads blocked with no "keep clear" due to traffic.</p>	<p>MB actioned on day</p> <p>PS met to discuss</p>

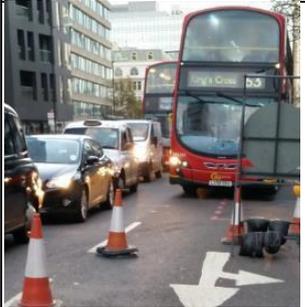
<p>Generally seen all along Blackfriars Road, large A frames not coned off from cyclists.</p> <p>Managements of sites generally not checking TM signage. Eg. approach to Webber Street, "Keep Left" signage .</p>	<p>PS consulted</p>

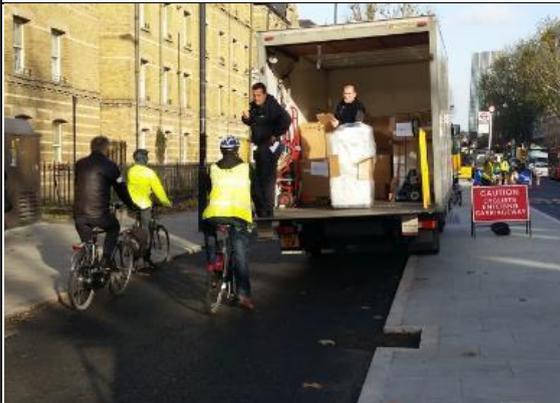
<p>Insufficient load bays, means residential deliveries vans/lorries blocking the cycle track.</p> <p>Lack of clear "cycle track" and parking/loading penalties signs.</p> <p>No "look left" "look right" signs on cycle track to warn pedestrians</p>	<p>Enforcement team has been consulted.</p> <p>PS to investigate.</p>

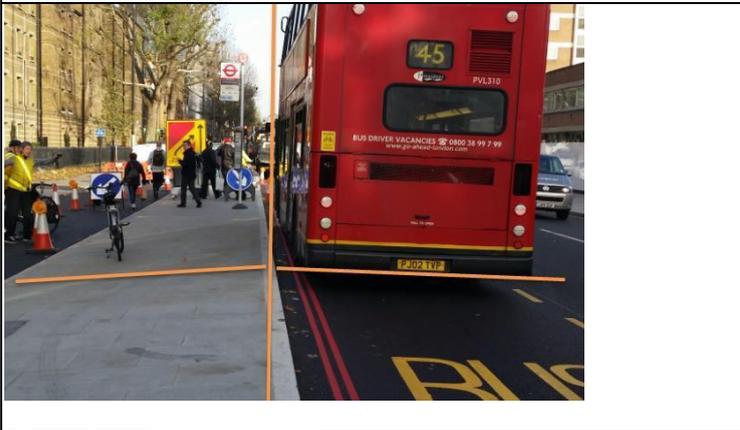
<p>Adverse cambers between bus and bus stop pavement. Disabled passenger reported to have fallen from wheelchair from exiting a bus.</p> <p>New and existing bus stops to have urgent safety review on road.</p>	<p>Sponsor team to be consulted</p>

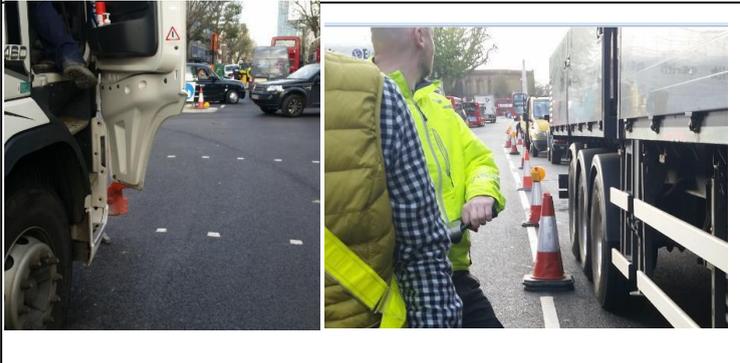
<p>Loss of available space as contractor vehicles using cone off areas as "parking".</p> <p>Essential access areas to be reviewed and formalized along Blackfriars Road</p>	<p>PS to review</p>

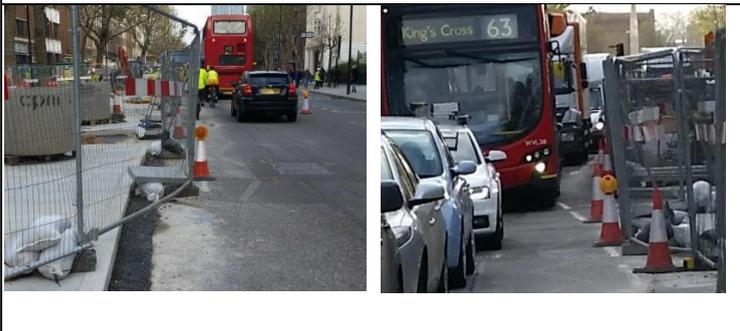
<p>Heras fencing creating unnecessary pinch points.</p> <p>Contractors not active in reviewing opportunities to make road safer to vulnerable users.</p>	<p>PS to review</p>
<p><b>Zone 8. St Georges Circus</b></p>

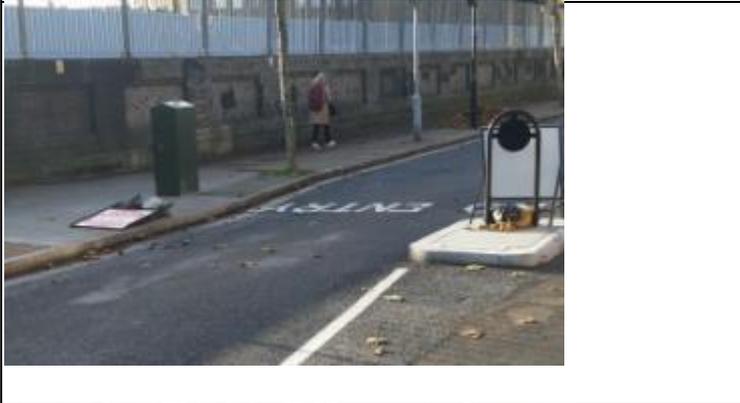
<p>TM signs not being maintained for "No Entry" signs.</p>	<p>PS to review</p>

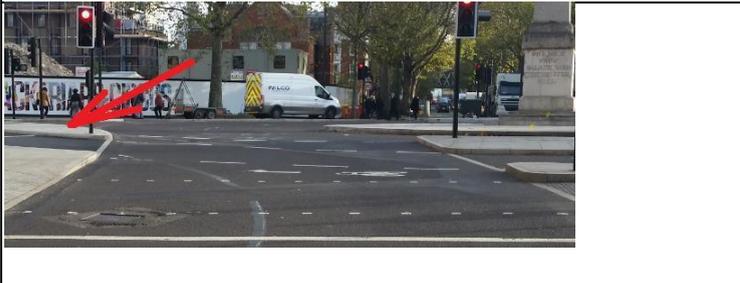
<p>In busy traffic, vehicles seen turning left incorrectly into CSH track off Westminster Bridge Road. No clear signage to stop this. Lack of painted cycle track adding to confusion.</p>	<p>Sponsor team to be consulted</p>

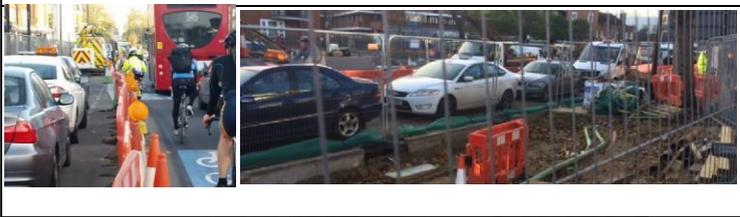
<p><b>Northbound:</b> Non-operational vehicles “parking” in TM. At junction pinch point vehicles could be more safely located to create more space for vulnerable road users.</p>	<p>AJ has been made aware and discussions on a way forward to be discussed.</p>

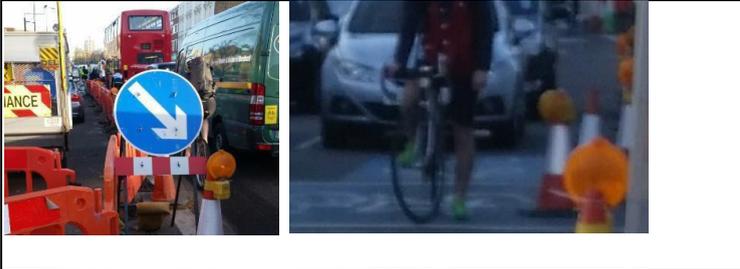
<p>TM cones and signage pulled in tighter.</p> <p>Contractor to improve TM management.</p>	<p>Acted on same day by TfI (MB)</p>

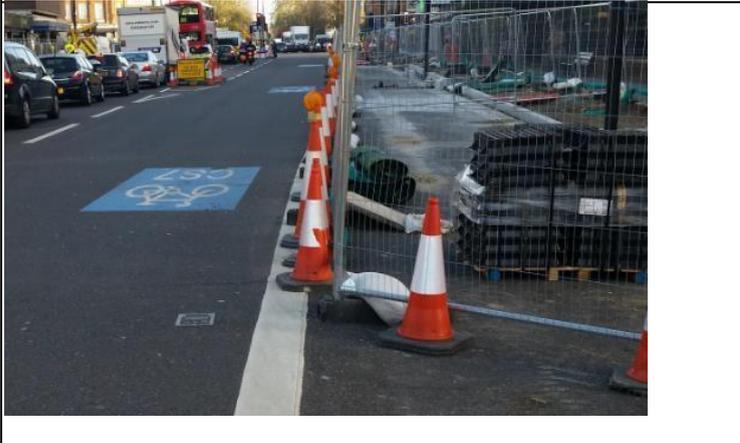
<p>Southbound: Heras fencing not needed as wide.</p> <p>PM to review if more space for cycles</p>	<p>AJ to review</p>

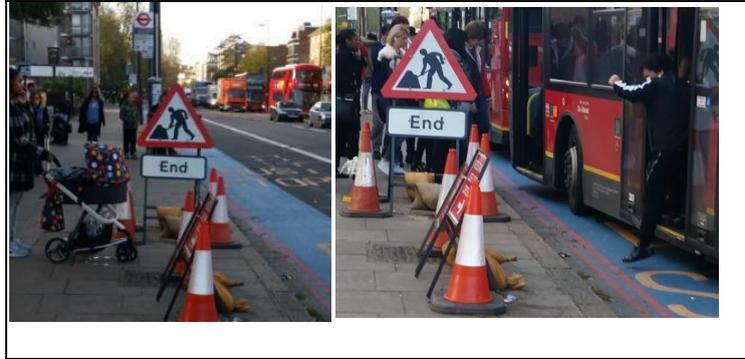
<p>Footway clutter blocking exit from bus (when two buses at very busy bus stop)</p>	<p>AJ to relocate TM away from bus stop</p>
<p><b>General Comments</b></p>		
<p>The standard patrol abilities and discipline to review TM daily was seen to be shockingly poor over most Highways contractor work sites.</p> <p>Following the (well advertised) blustery conditions of the previous night many TM signs and barriers were left fallen, with some causing immediate highway dangers, or re- erected incorrectly. Current working discipline by Contractors is not sufficient, nor reliable, nor safe.</p> <p>Heras fencing banners flapping loose in the winds, and hazard to be added to standard patrol checks.</p>		<p>MB to discuss with PMs</p>
