# FOCUS ON HIGHBURY CORNER BRIDGE REPLACEMENT WORKS

Roadworks Patrol – 20<sup>th</sup> April 2017 (9 AM ride)

A focus on the Highbury Corner

This scheme has been implemented to replace the existing bridge structure at Highbury and Islington Station. To facilitate the works various traffic management layouts have been installed to manage pedestrians and all vehicular traffic. Concerns have been raised on pedestrian and cycling safety negotiating these works which the patrol aims to mitigate where practicable.

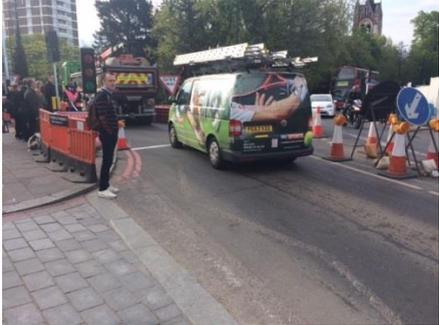
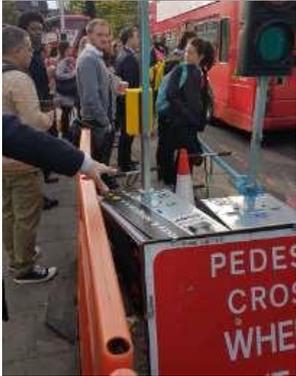
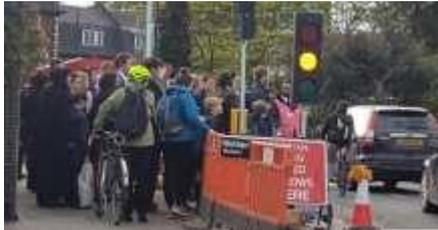
ISSUES & ACTIONS
<p>Temporary crossing Highbury Corner</p>

<p>General lack of space for pedestrians</p> <p>vehicles on stopline lose visibility of the lights and is a safety concern  <b>move stop line 1m+ back from existing location to give visibility of lights and increases safety zone</b></p> <p>Side by side placement of the signals is taking up space  <b>Re-align signal position lengthways and move TM in</b></p> <p>Some cones are un-necessarily positioned in the road after drop kerb  <b>To be removed (keep one either side)</b></p> <p><b>“Pedestrian crossing when red light shows stop here”</b>  <b>Is this required as there is an existing stop line?</b></p>

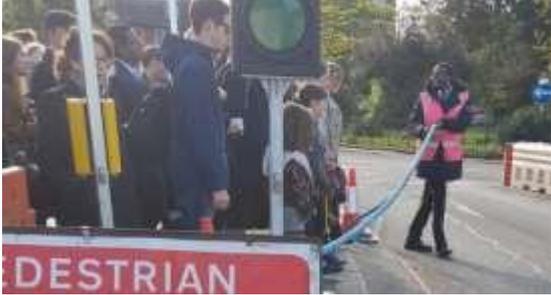
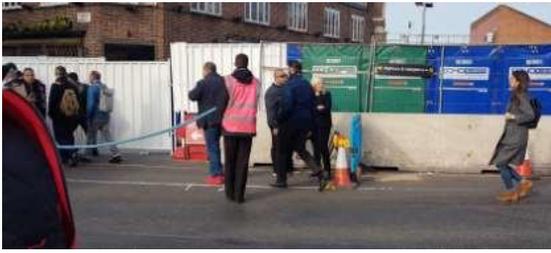
<p>White lining is becoming worn  <b>Re-line to highlight edge of carriageway</b></p> <p>Marshals in pink and using a blue rope</p> <p><b>Marshals holding traffic should wear hi-vis to BSEN 471 with long sleeves. Yellow is more appropriate for carriageway activities.</b></p> <p><b>A red and white retractable tape is best fit to match existing set up and in addition to use “stop works signs”“lolly pop sticks”</b></p>

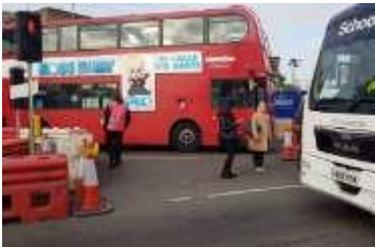
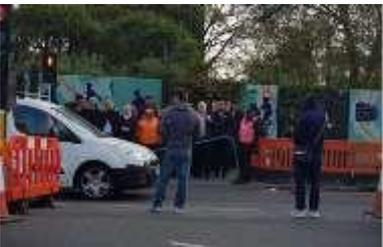
<p>Demarcation of central island worn  <b>To be re-lined to highlight the area</b></p>

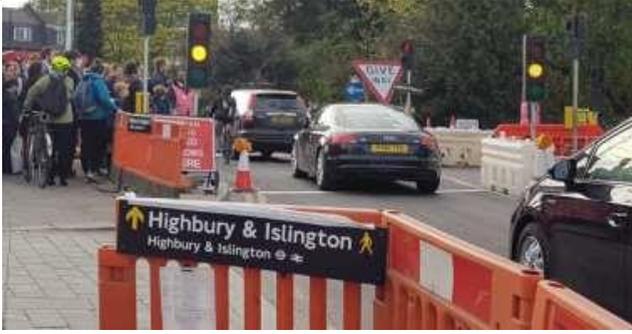
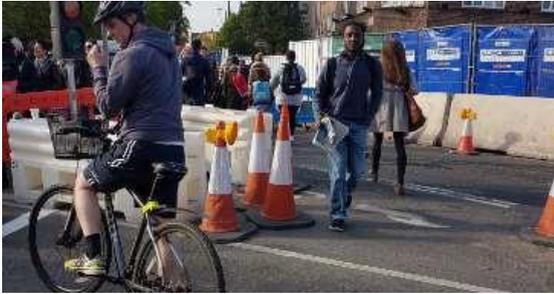
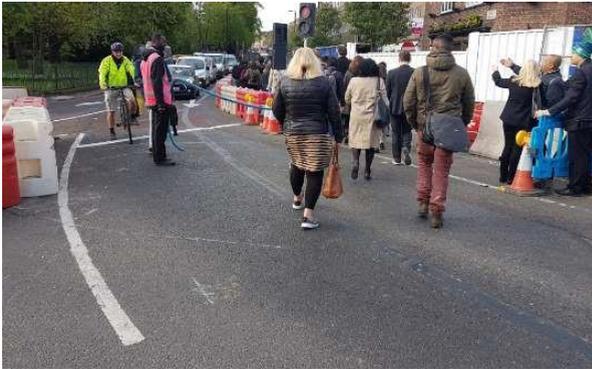
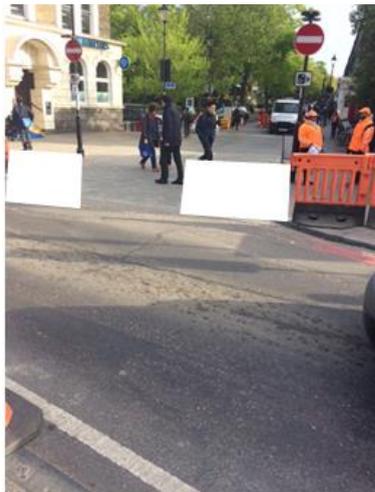
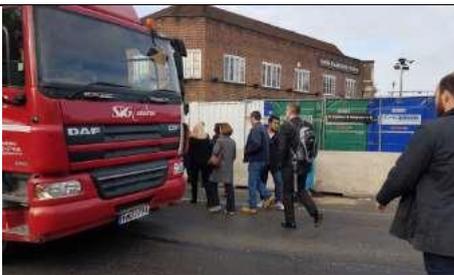
Highbury Place

Highbury Place, used by cyclists only is leaving opportunity for pedestrians to follow a desire line across the road.

HGVs often seen blocking the signals and crossing areas

**Suggest tweaks to the central right turn pocket and narrow the bell mouth area with signage for cyclists only.**

**example for potential method to the left.**

**To look at options to highlight where the crossing area is either by studs or an alternative method**

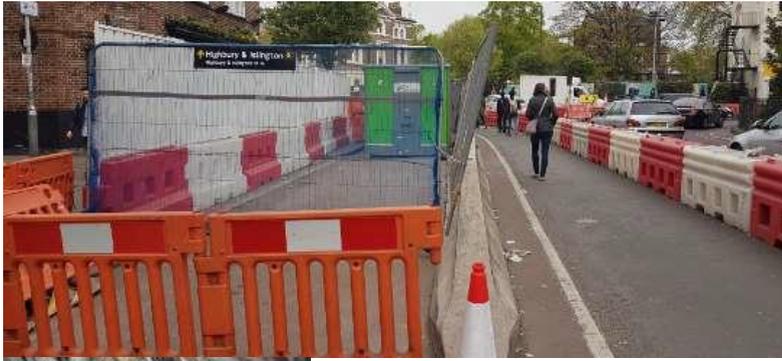
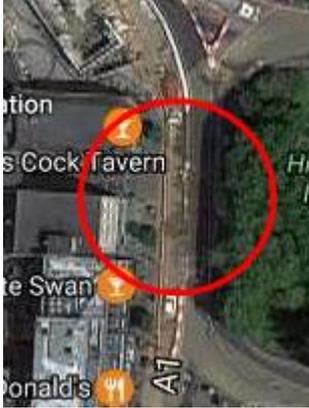
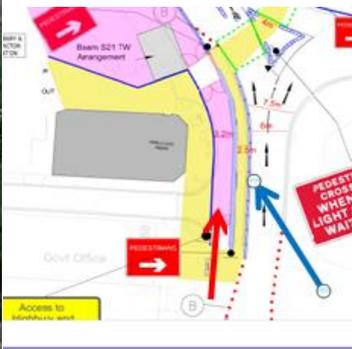
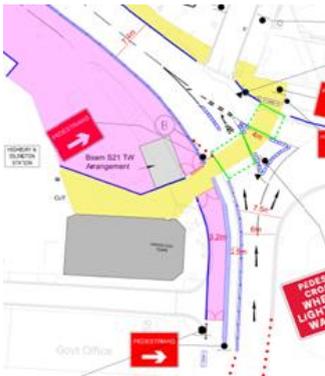
Water filled barrier location has caused limited width for the slip road off the gyratory. Vehicles observed to sit over the centre line (circled area) which is blocking traffic wishing to travel clockwise around the gyratory.

Previous layout (to left) was not seen in use

**Suggest to relocate welfare unit and use the closed off vehicle access area presently used weekends only (questioned with welfare unit) only for pedestrians (red arrow) during the week when the foot fall is higher. The barriers can be brought in (blue arrow) leaving 2m for pedestrians, for weekend use (lower footfall) when the access is required and gain back a full traffic lane.**

**This will help improve traffic flows around the gyratory and reduce the negative impacts (congestion, pollution and bus delay)**

**Alternatively, as per arrangement shown – to open the gates to allow weekday pedestrians direct access to the crossing and follow barrier width changes as per blue arrow above.**

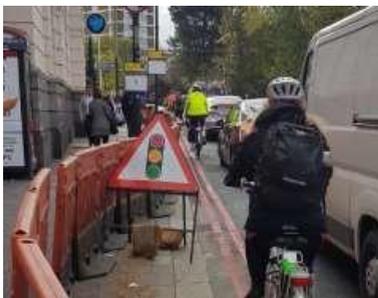
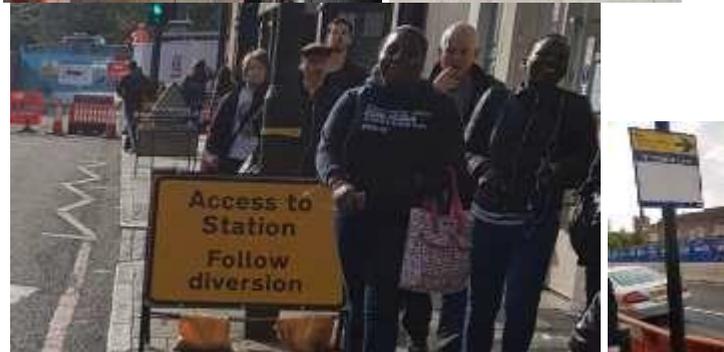
Signage clutter observed around entire works footprint causing obstructions to pedestrians and cyclists.

**Suggest an arranged site patrol to remove all non required signage and sand bags and to relocate large required signs from the floor to redundant posts or lighting columns.**

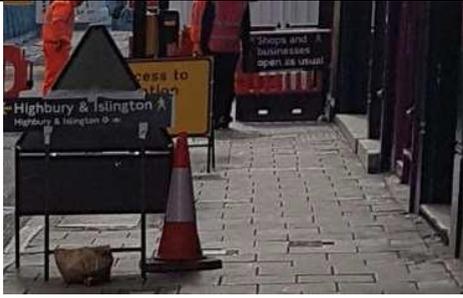
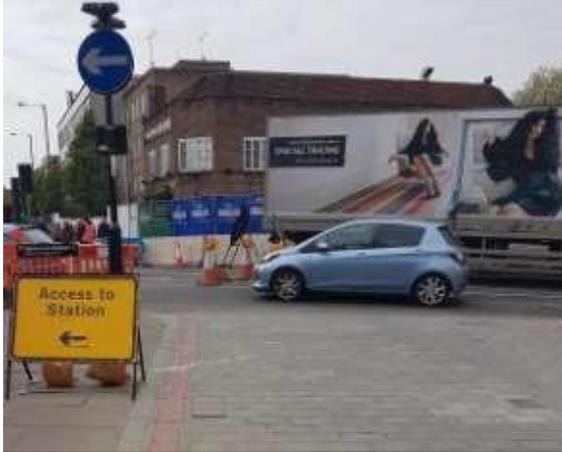
Inconsistent direction signage around works footprint

**Project team to review**

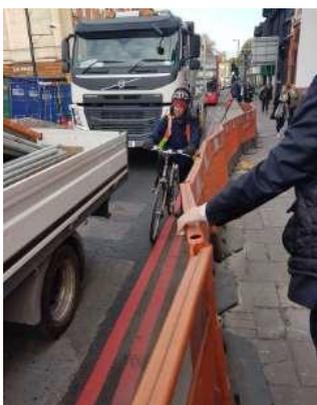
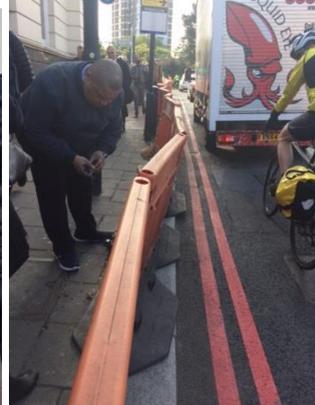
Some fencing areas observed leaning into the carriageway causing obstructions to cyclists.

**Site patrols to ensure fencing straight and behind kerblines.**

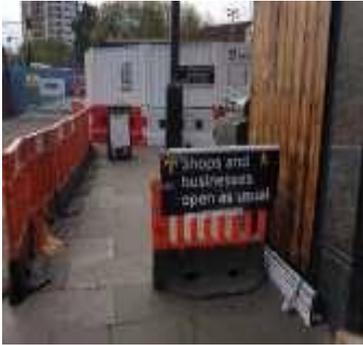
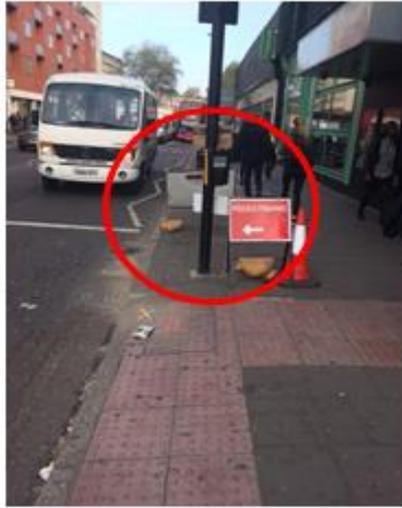
Signage for hidden local business is barely visible with some signage observed attached to signal poles

**Suggest investigating alternative methods to highlight these shops are still open for business**

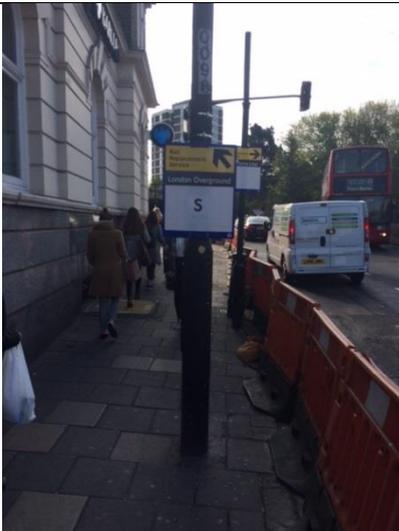
Some temporary signage was observed too low leading to public safety concerns

**2 x signs removed on the day due to low height.**

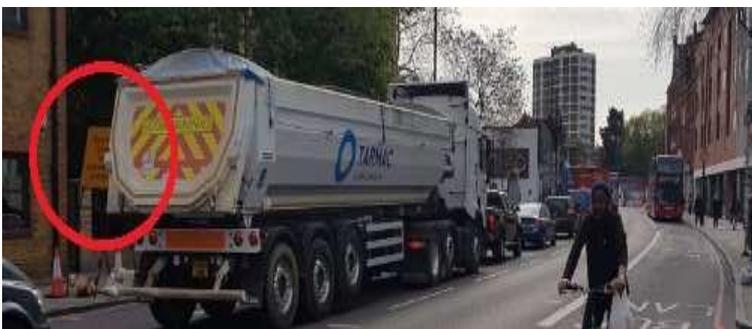
Poor placement of "no overtaking cyclist's signage". This was next to an open bus lane too far in advance too site.

**Suggest consistent and pragmatic approach to place signage where there are conflict areas**

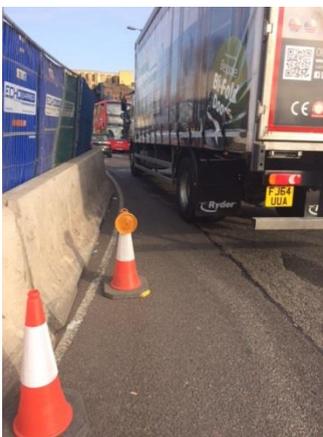
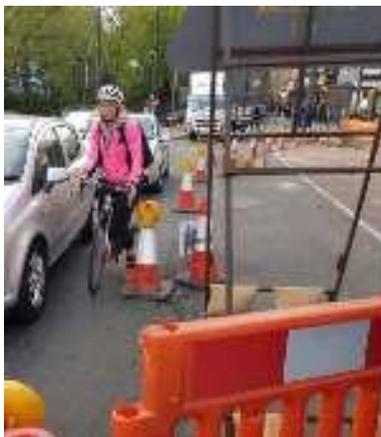
Patrol observed various locations where cyclists struggled

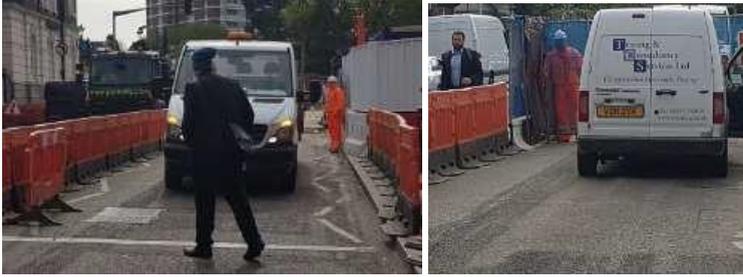
Site vehicles observed to cross the pedestrian crossing to access the site during the green man phase.

**Drivers were warned and instructed not to repeat exercise.**

**Also to investigate alternate methods to access site**

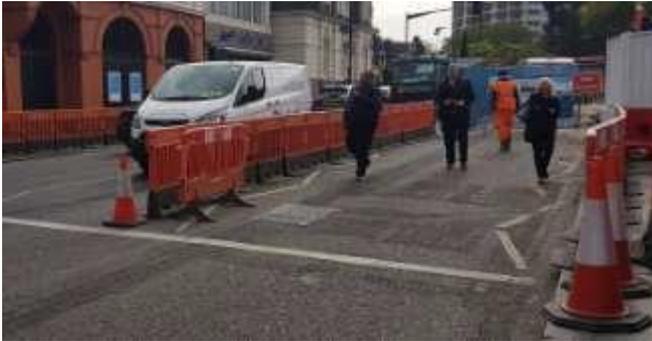
Area width causing narrow traffic lane

**Suggestions to investigate width be revised to give a wider running lane**

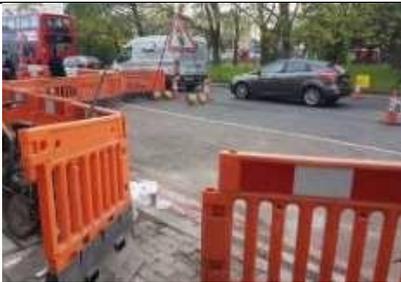
Public may have been undoing TM to cross the road

**Patrol required to identify areas of where TM has been removed and re-fix/position.**

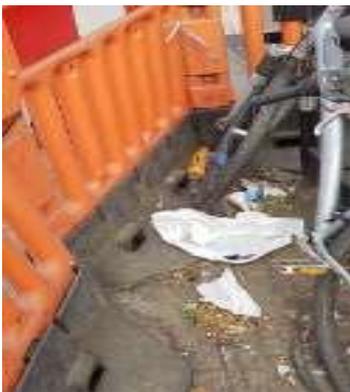
General unclean environment around site footprint.

The water filled barriers are used to insert litter

Site hoarding is very angular which can invite potential crime (ambush points) and corners which may be used as toilets

**Suggest site standards are raised with local authority cleansing involvement**

**Liaise with suppliers to investigate methods to cover (with angles) the top of the barriers.**

**Suggest auditing area to smooth of specific areas and check sufficient lighting at night**

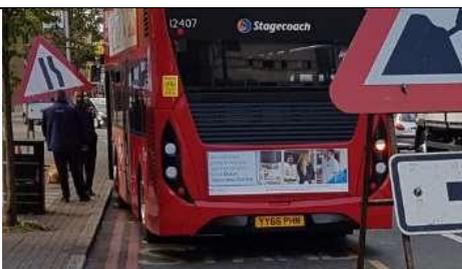
Bus stand access obstructed by signage positioning

**Suggest relocation**
