Road Works

Tideway Patrol

30 August 2018

All Inclusive Cycling
and Walking at
Roadworks Report

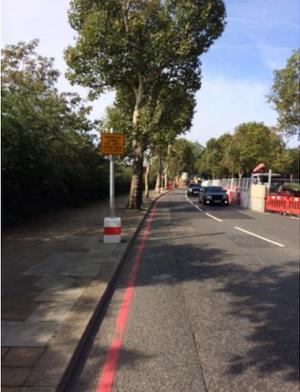
<p>Change of environment from blue mandatory lane to uncomfortable area to cycle.</p> <p>Investigate more 20mph roundels on the carriageway and smiley face actuated signs</p>

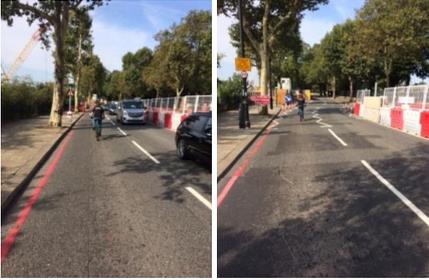
<p>Section benefits from downward slop to aid cyclists to maintain and match traffic speed and help with position</p>

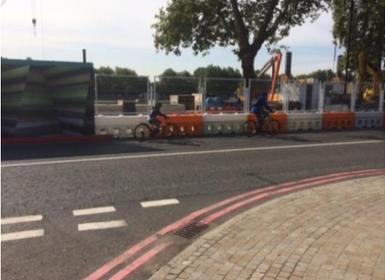
<p>Some young cyclists were seen using the route</p> <p>Monitor cycling demographics and maintain conversations with local cycle groups</p>

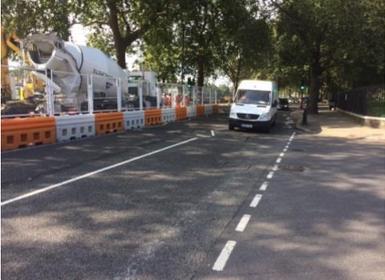
<p>View of pedestrian crossing impeded by site vehicle and hoarding alignment</p> <p>Investigate opening end of hoarding or relocate crossing to supply more visibility of those waiting to cross</p>

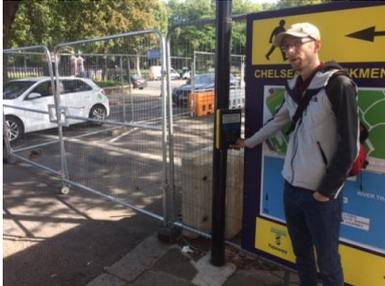
Example of above noted issue

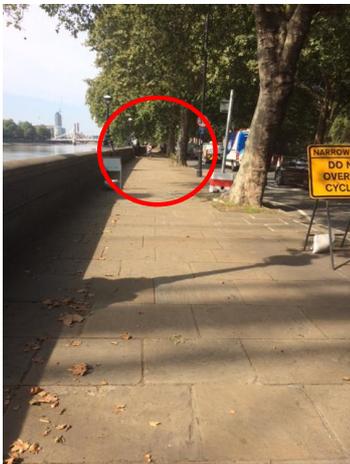
Lady observed cycling on footway. When asked she highlighted this was due to unsafe feeling on the carriageway

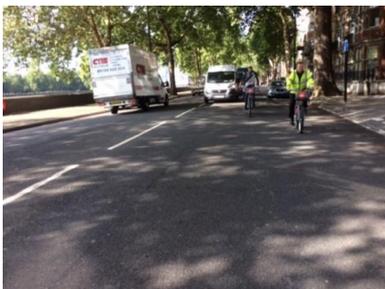
On exiting site area the road widens and reduced conflict.

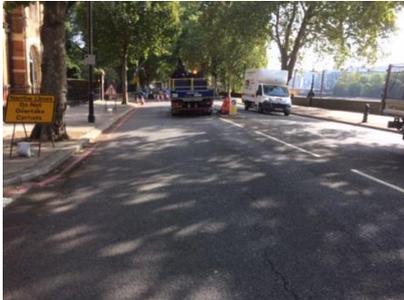
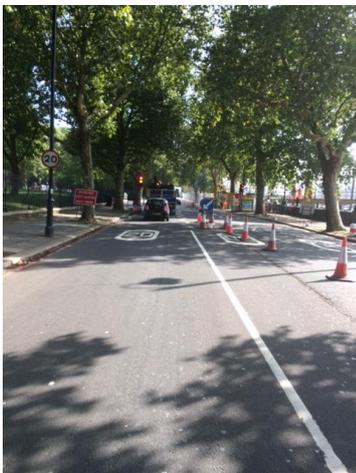
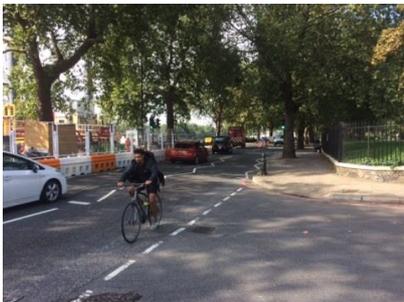
Narrow lane and warning signs in place. However, due to tree trunks, canopies and shadows advance signs weren't easy to pick out.

Once cycling passed the first section on this approach, there are escape routes for cyclists eg the Bull Ring and footway.

As this stretch is uphill we found we had drivers especially HGVs driving up close which was intimidating.

Investigate locating extra signs in the centre of carriageway to highlight works area ahead.

Also to check lighting levels as winter nights draw in.

Introduce speed reduction measures

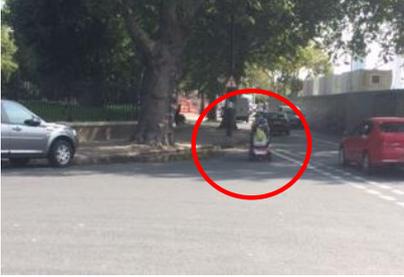
Wheel chair user observed struggling around ponding

Contractor to undertake frequent patrols of footways to ensure pedestrians can negotiate at all times.

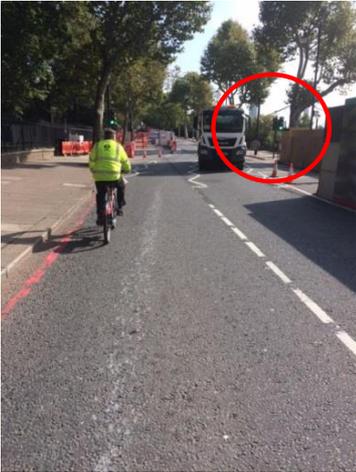
As with the western side of the site, visibility of pedestrians waiting to cross is obscured by the hoarding location

Investigate alternative methodology to open up view

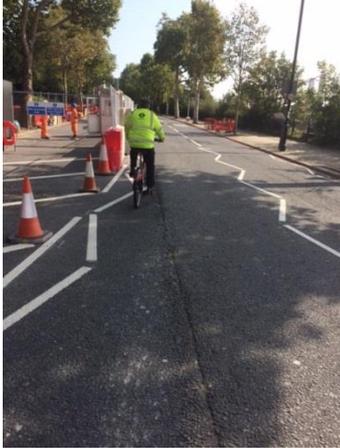
Pinch point on the uphill section felt uncomfortable to cycle with some vehicles driving close.

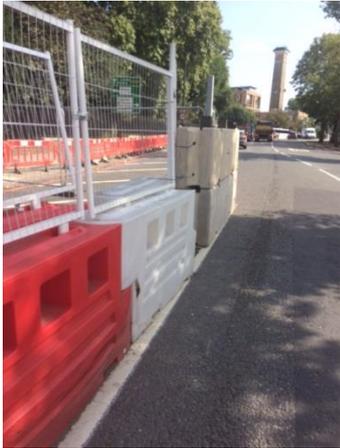
Double concrete VCBs at head height causing a need to cycle further into carriageway as not to touch handle bars against the side.

Investigate alternative traffic management type.
