FOCUS ON TIDEWAY CYCLING MITIGATION

Roadworks Patrol – 19TH June 2017

A focus on the Tideway Scheme

Observations & Recommendations (TfL), Tideway response(TW)

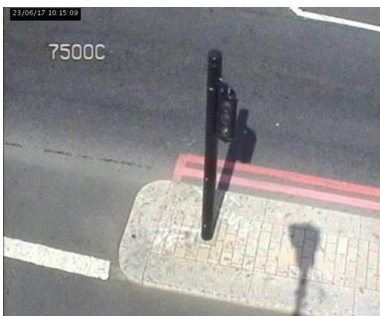
Road cyclists/mopeds at risk at pinch point. Insufficient warning of narrow lanes ahead

Suggest general traffic “Narrow Lanes Ahead” warning and 20mph speed restriction.

Tideway to review with TfL

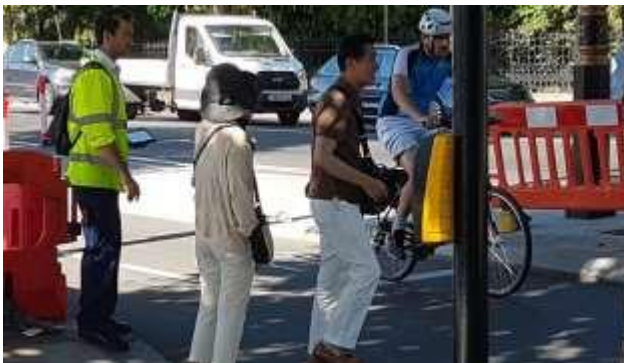
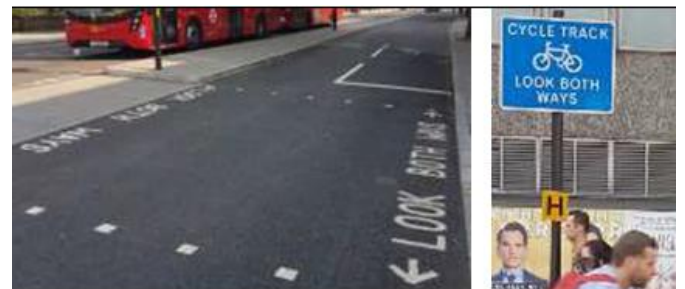
Central island push buttons obstructed by traffic management

Relocated on the day

Tideway to constantly monitor site and review existing layout and temporary design

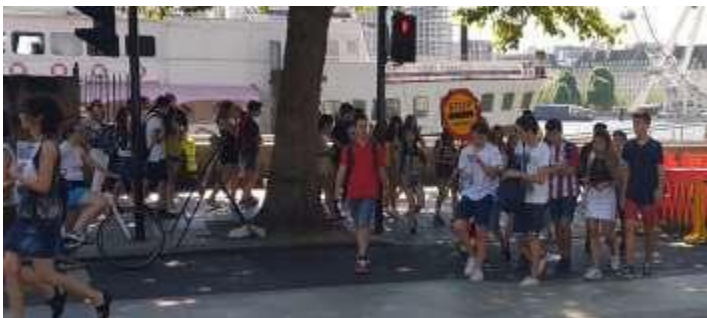
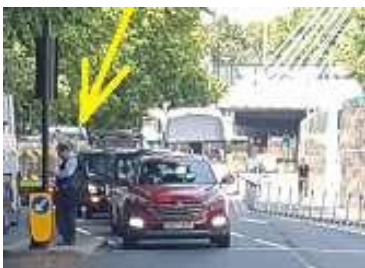
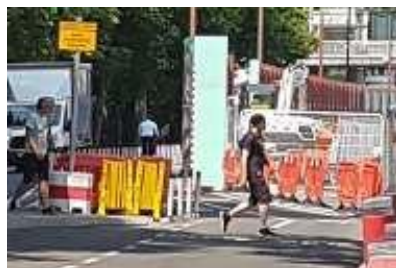
Pedestrians may be enticed to wander passed the closure points which leads to security concerns for all parties especially during the night.

Tideway to review all diversion signage and way finding. Also to investigate early diversions

Suggest more robust traffic management and liaison with the moored party boats for a collaborative approach on security.

Tideway to investigate section 17 mitigation measures with TfL and Police.

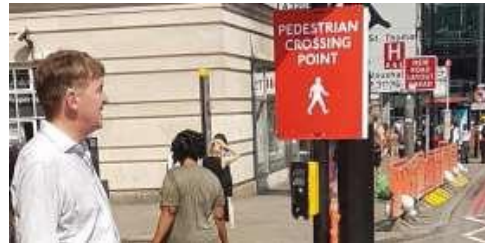
Existing signage may be unclear to pedestrians hence using cycle track for thoroughfare. Eg use alternative below:

Tideway to review all signage locations, signs used and the message being put across.

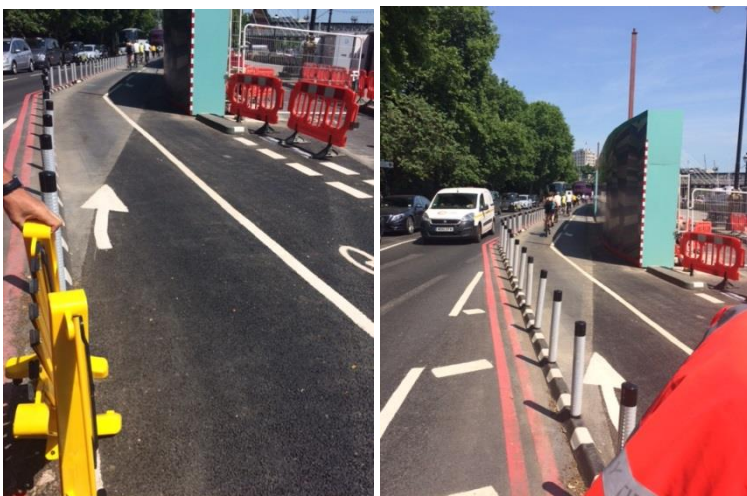
Marshals observed using two attached concertina barriers which often came undone.
